PROJECT: Thorne Road Off Dock Container Yard

SUBJECT: Summary of Potential Areas of Soil and Groundwater Contamination

DATE: February 25, 2020

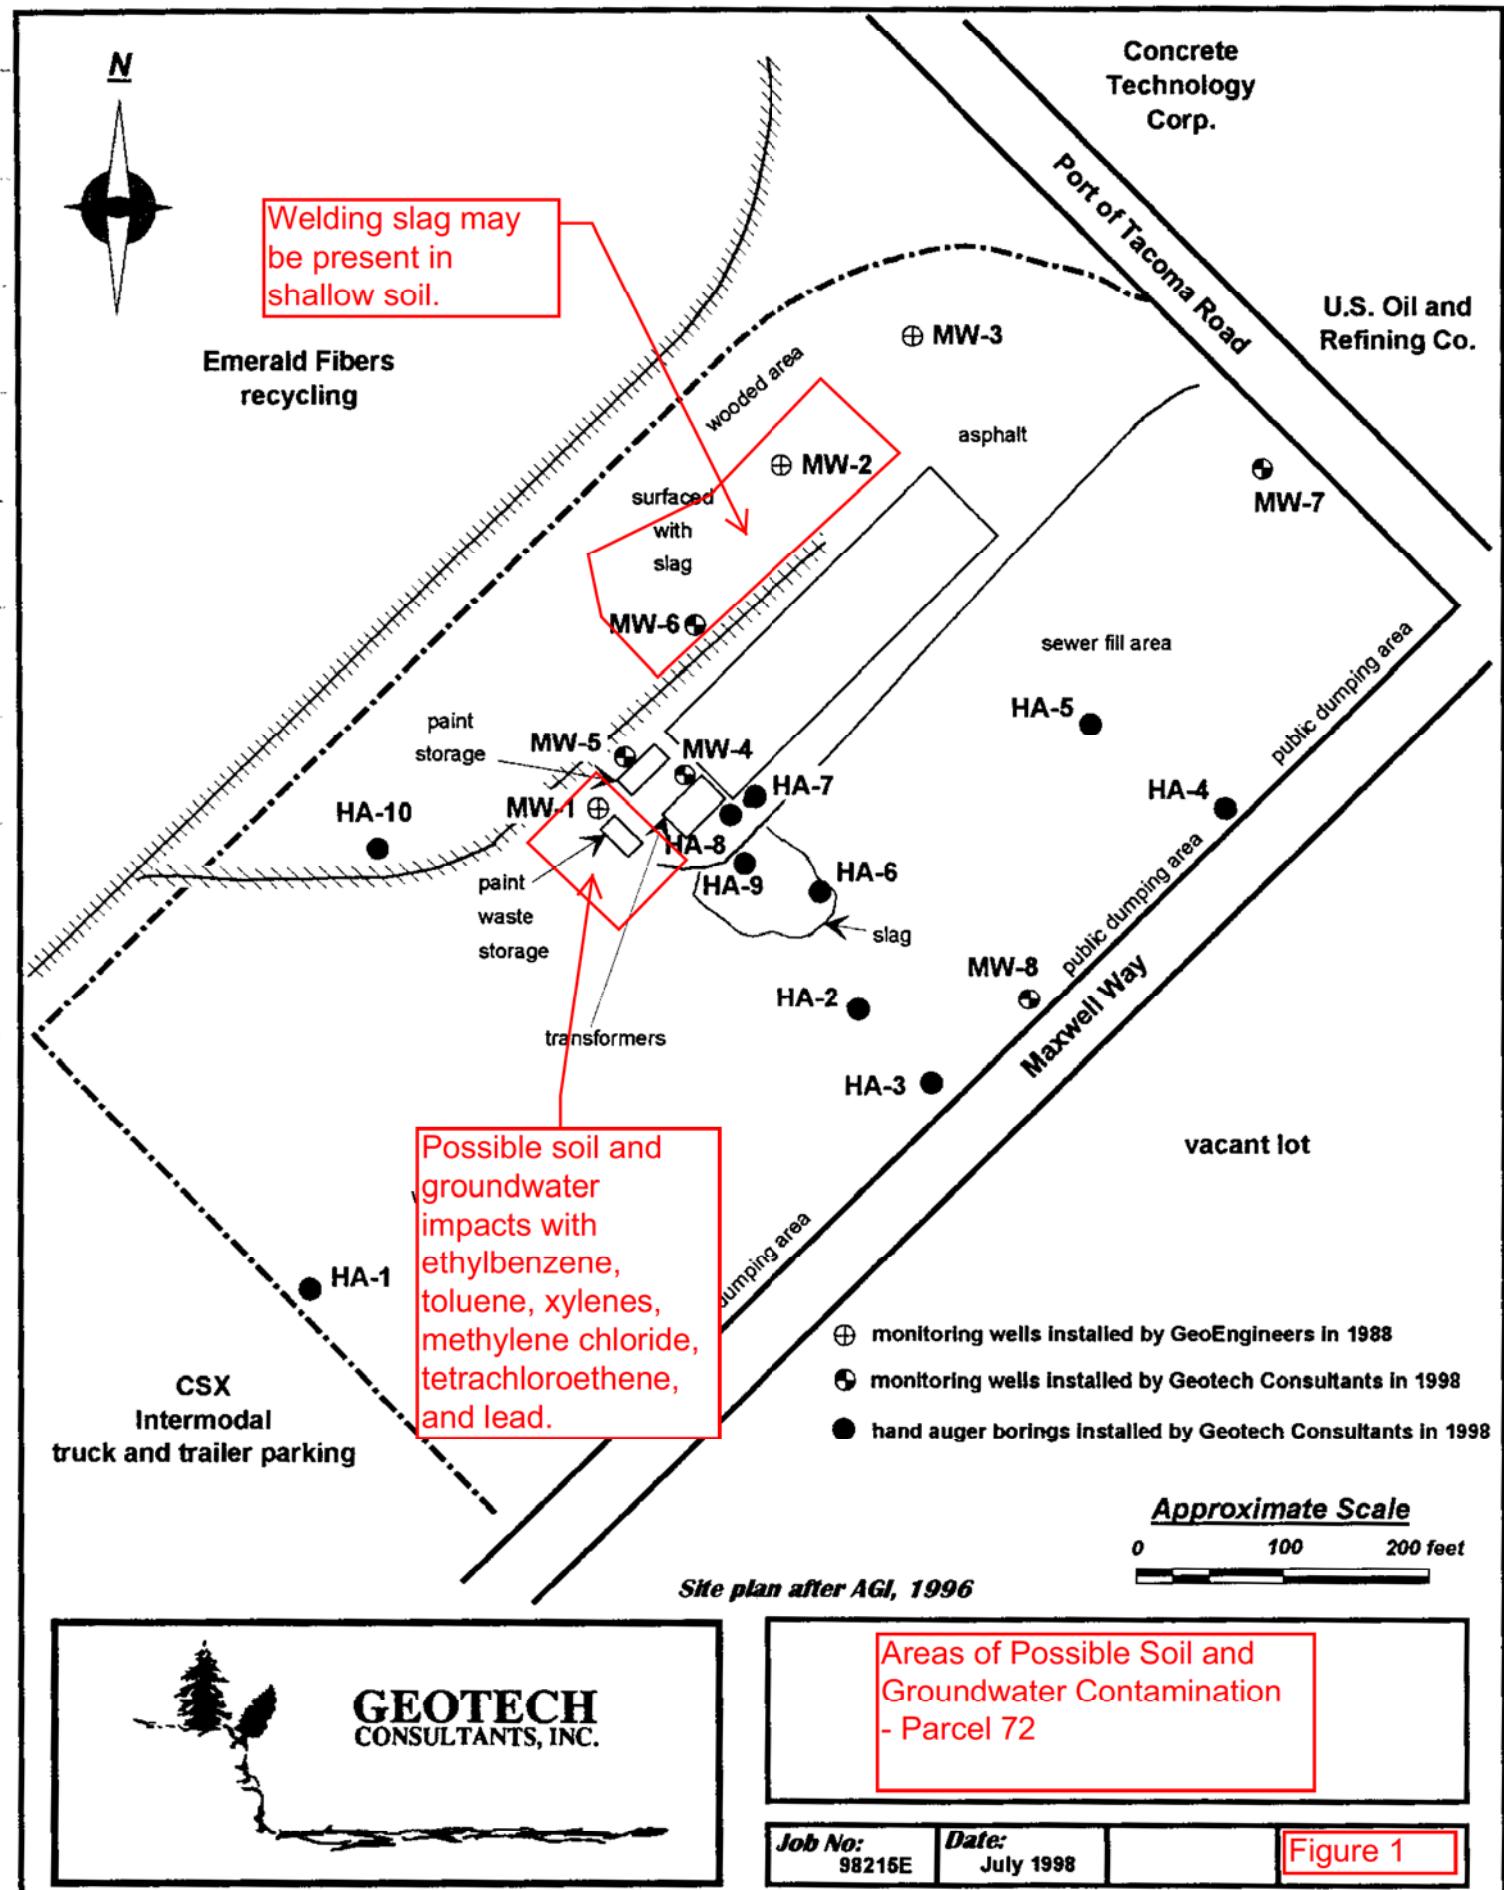
Based on these data, the following areas are identified on Figure 1 that have potential contamination remaining in soil and groundwater:

- Paint waste storage area has potential soil and groundwater contamination, including ethylbenzene, toluene, xylenes, methylene chloride, and tetrachloroethene.
- Welding slag may be present in the parking area north of the former building.

As with any project, soil and groundwater contamination may be uncovered during grading and excavation activities and any suspected contamination should be reported to the Port.

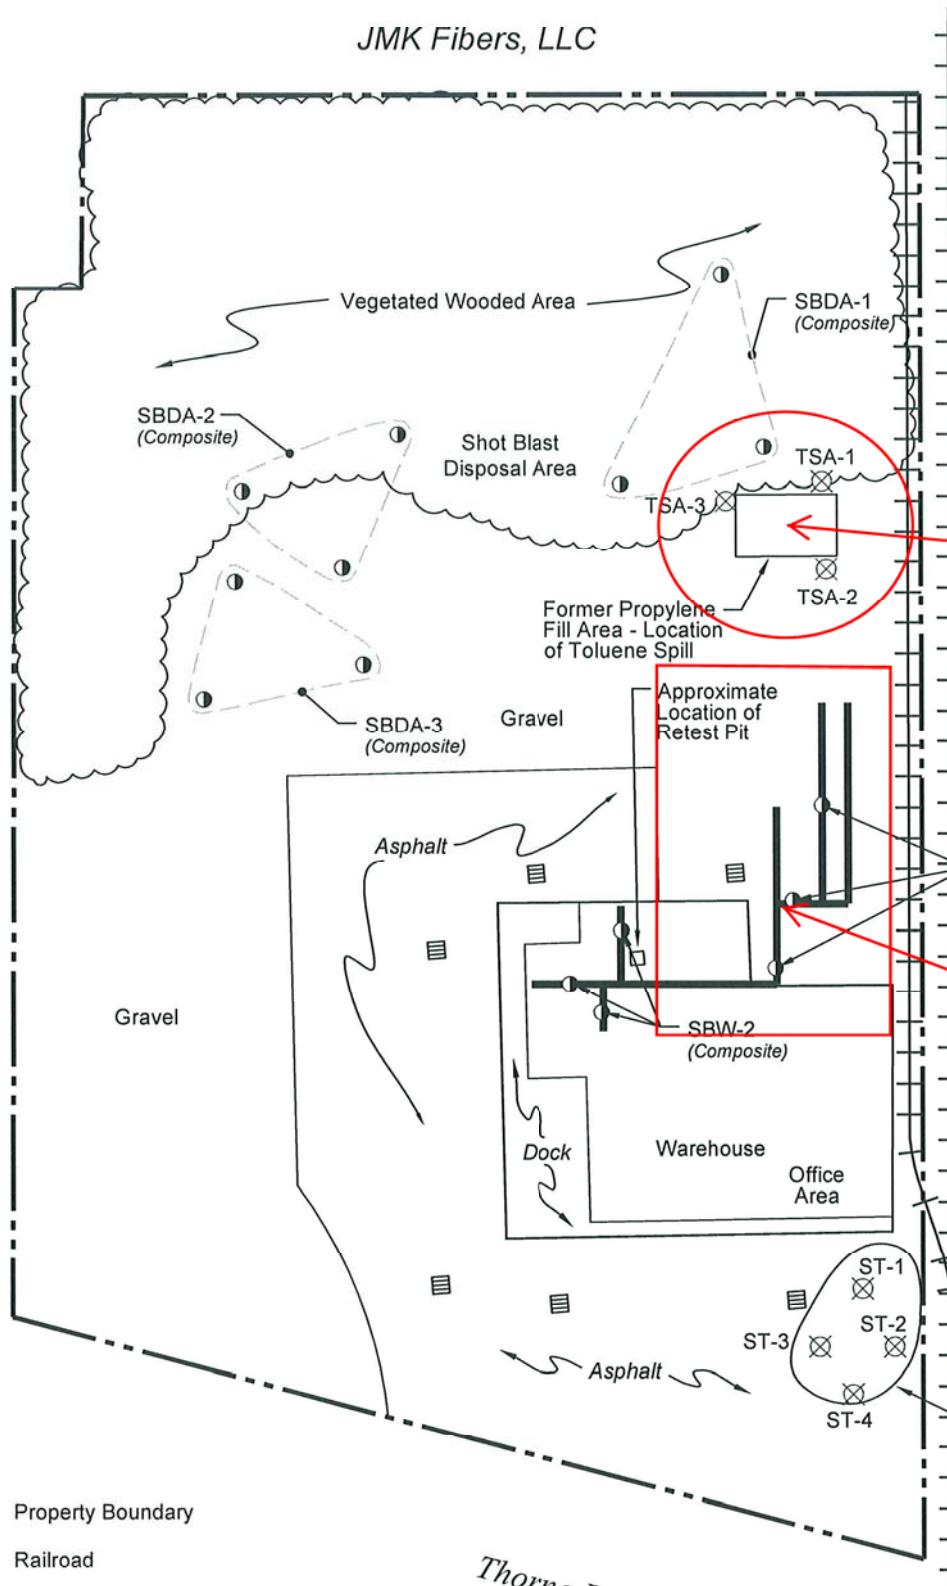
Based on these data, the following areas are identified on Figure 2 that have potential contamination remaining in soil and groundwater:

- The toluene spill area has potential toluene groundwater contamination.
- The former concrete trench areas have potential metals contamination in soil from the shot blast waste.

Areas of Possible Soil and
Groundwater Contamination
- Parcel 85

As with any project, soil and groundwater contamination may be uncovered during grading and excavation activities and any suspected contamination should be reported to the Port.
