**Port of Tacoma – Straddle Carrier Shop  
Roof Evaluation  
SITE VISIT – March 24, and April 7, 2016**

April 26, 2016

Ref: Pierce County Terminal (Evergreen)  
Maintenance Facility Straddle Carrier Bays  
Port of Tacoma Road  
Tacoma, WA

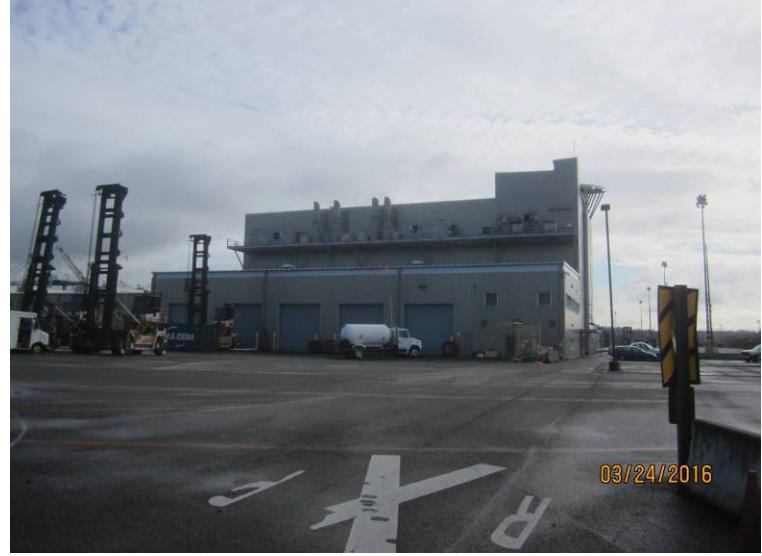
Photograph 1: Overview of the Straddle Carrier Shop.

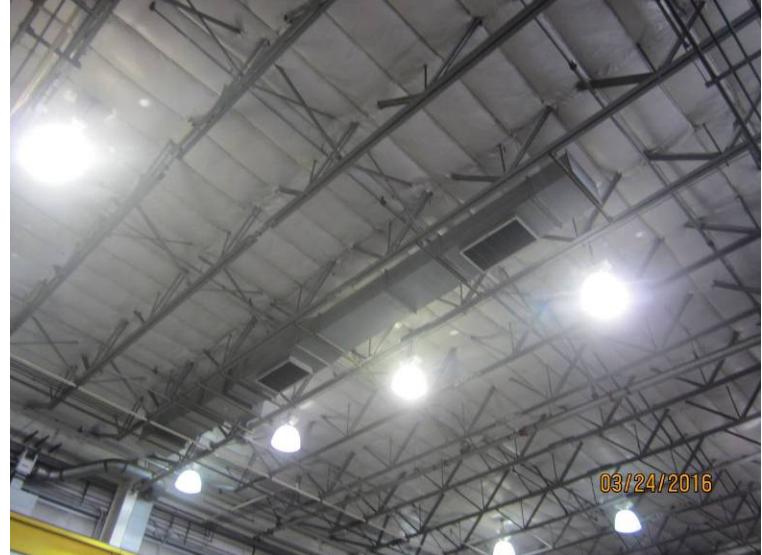
Photograph 2: Looking up at the underside of the roof deck with PSK vapor barrier.

The batt insulation below the roof deck is displaced or missing in several areas and the vapor barrier is discontinuous. The batt insulation should be reworked to provide a full coverage, and the vapor barrier made continuous at all locations. This work may help prevent water accumulation as a result of condensation.

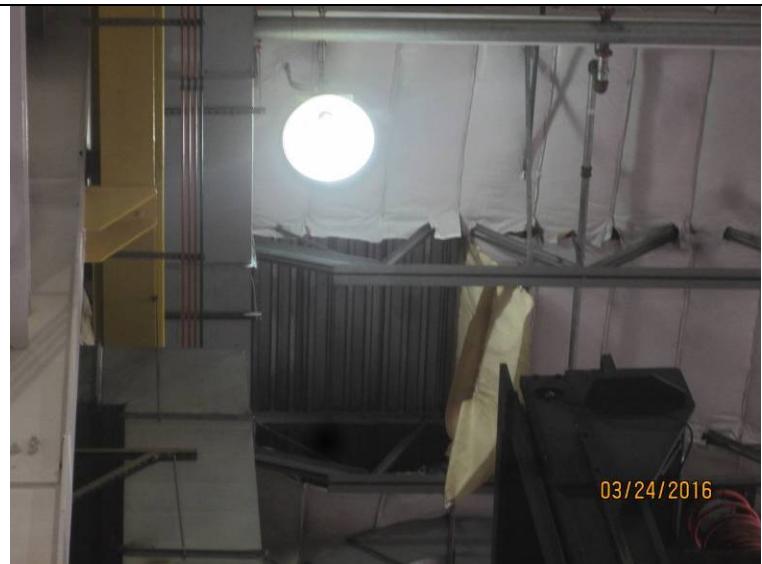
Photograph 3: A location of missing insulation exposing the underside of the metal roof deck.

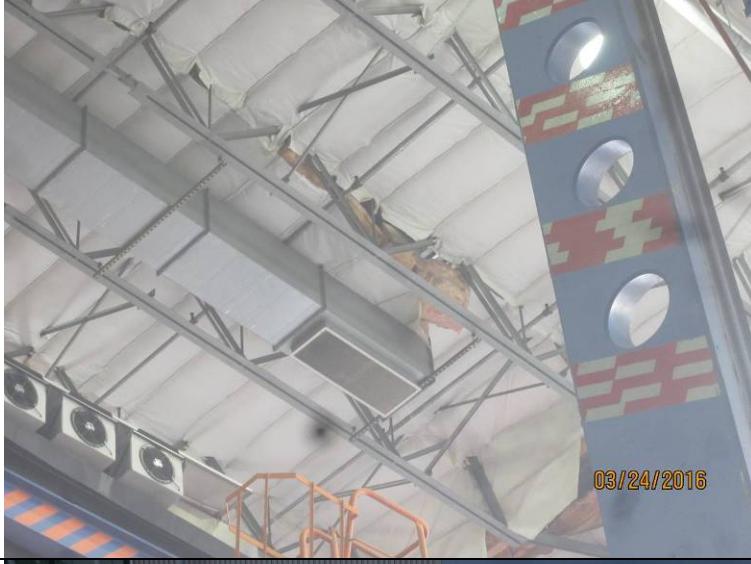
<p>Photograph 4: Displaced insulation and discontinuous vapor barrier.</p> <p>The voids in the insulation show up as dark spots in the infrared photographs.</p>

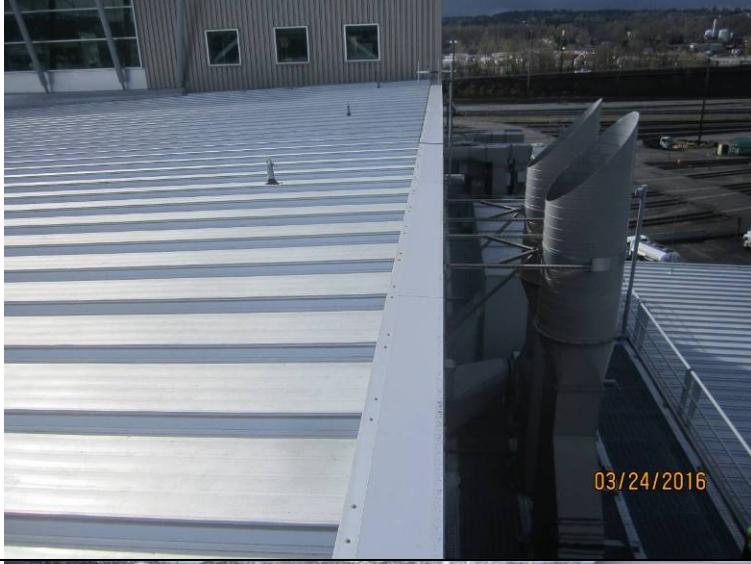
<p>Photograph 5: Looking south along the upslope edge of the Maintenance Roof.</p> <p>Edge metal is in place hooked into a cleat at the exterior and secured to z-closures at the interior of the roof.</p>

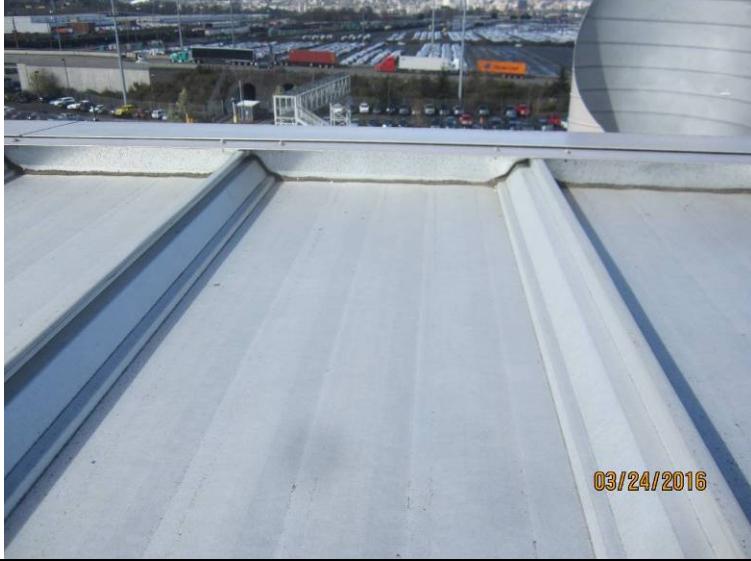
<p>Photograph 6: Looking upslope at the upslope edge flashing and z-closure.</p>

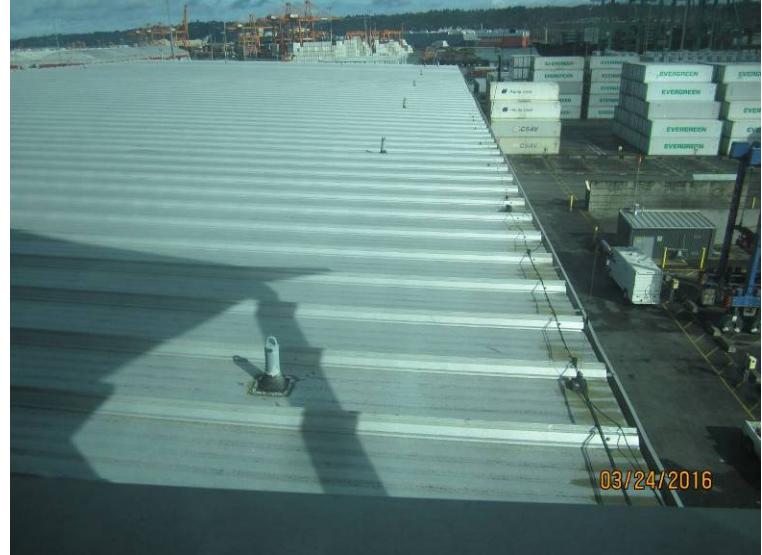
<p>Photograph 7: Looking north along the draining edge of the Maintenance Roof.</p>

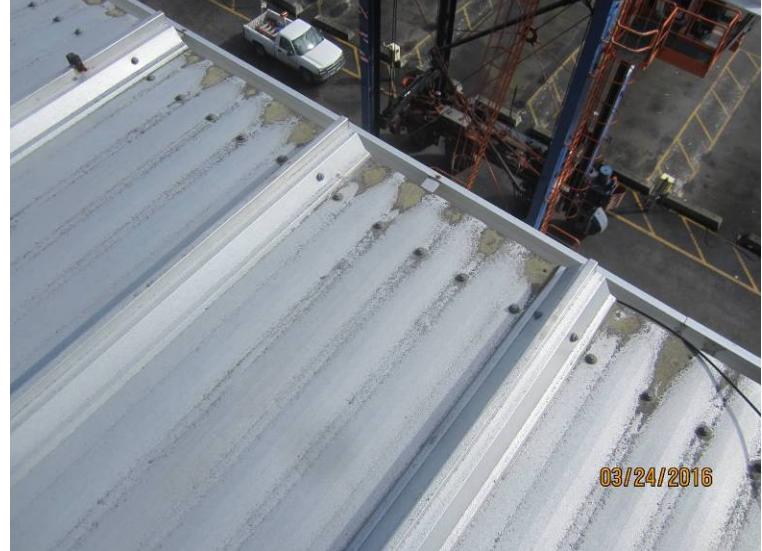
<p>Photograph 8: View of the draining edge of the Maintenance Roof.</p>

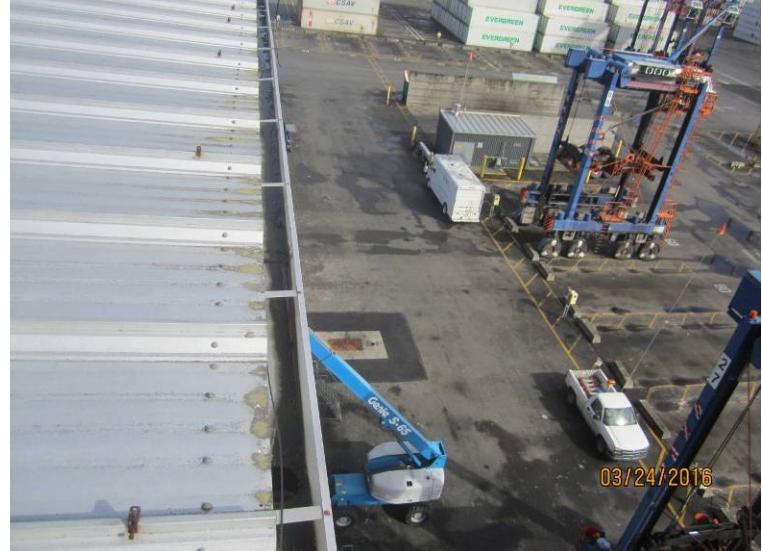
<p>Photograph 9: Overview of the external hung gutter at the east side of the Maintenance Roof.</p>

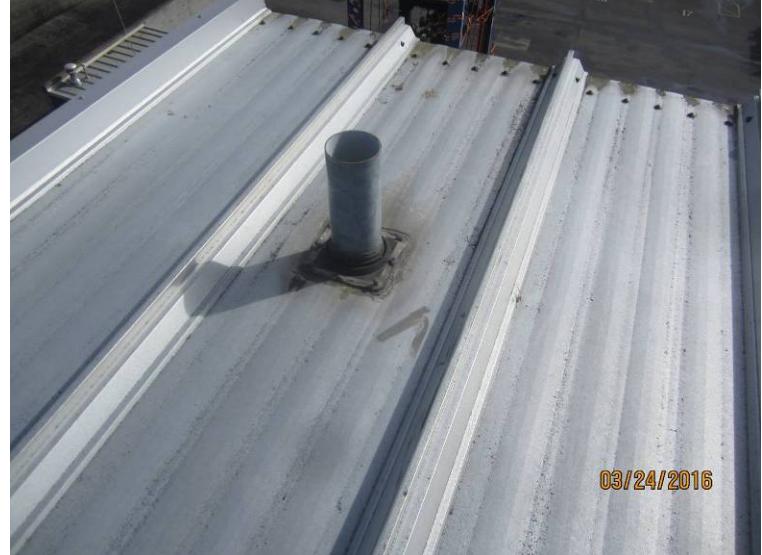
03/24/2016	Photograph 10: Typical pipe penetration flashed with a Dek-tite style flashing.

The water entry through the roof may be remediated by replacing the through roof flashing with new flashings, secured to the metal panels set over butyl tape/sealant. The top of the flashings should have sealant and stainless steel band clamps installed. The galvanizing relief holes should have sealant applied over the holes to prevent water entry. Fill the fall protection anchors with spray foam insulation to minimize condensation.

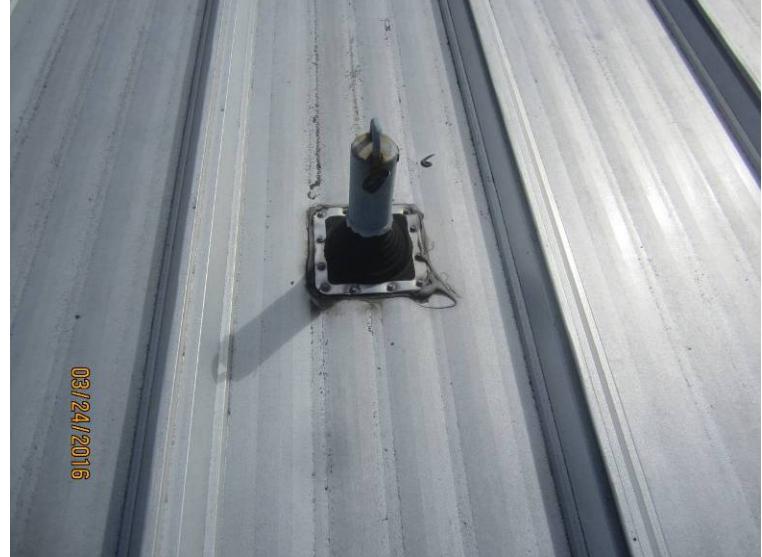
Water penetration through the roof panels appears to be entering at the through roof penetrations, specifically through the fall protection anchors. The galvanizing relief holes appear to be allowing water into the building. The plastic plugs where in place do not offer adequate protection from water entry. Additionally the through roof penetration flashing are likely compromised which provides another pathway for water entry into the building.

03/24/2016	Photograph 11: Typical fall protection anchor flashed with a Dek-tite style flashing.

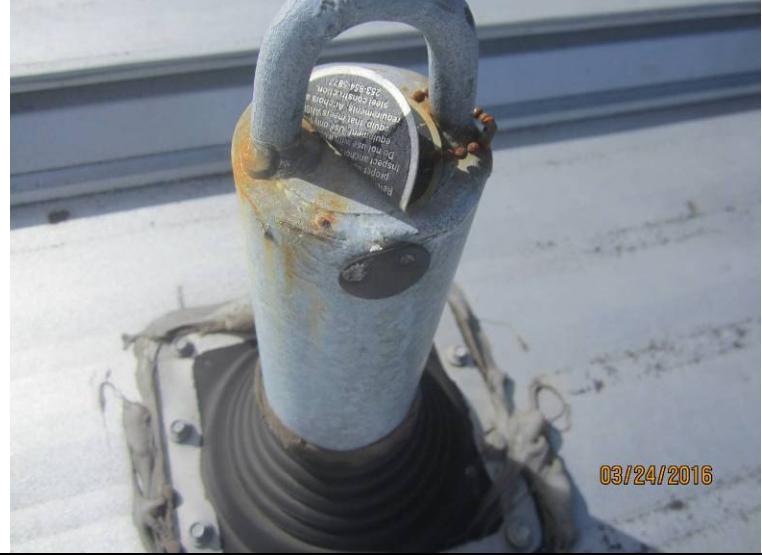
03/24/2016	Photograph 12: Plastic plug placed within the galvanizing relief hole.

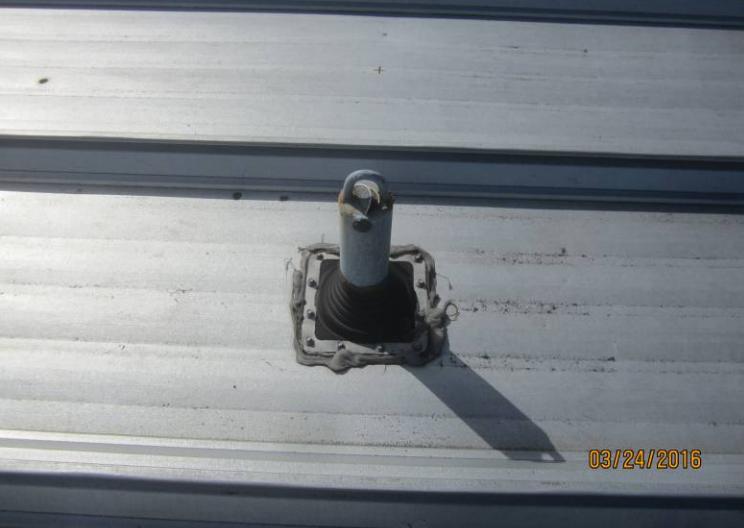
03/24/2016	Photograph 13: Sealant applied at the transition between the through roof penetration flashing and the metal roof panel.

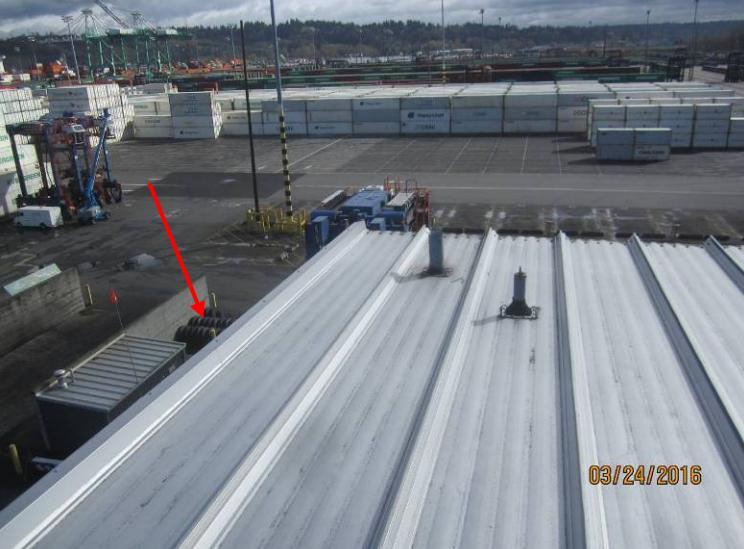
03/24/2016	Photograph 14: Overview of the North rake edge at the Maintenance Roof.

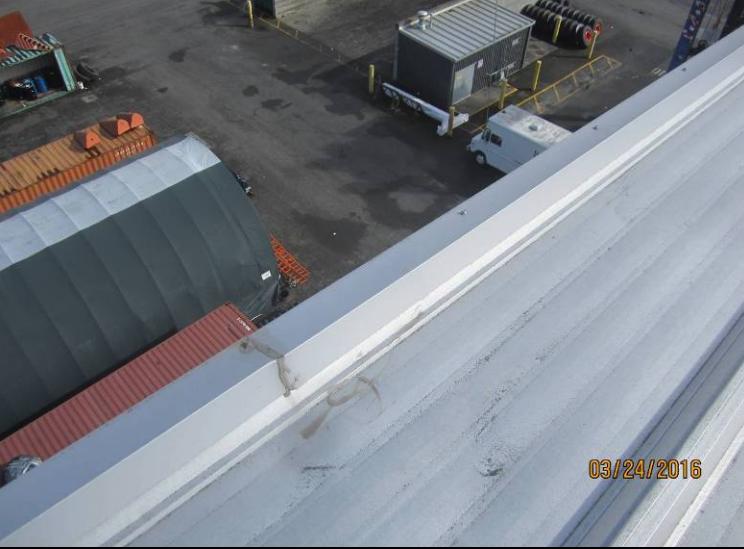
03/24/2016	Photograph 15: Closer view of the sheet metal cap at the rake edge, the cap is top fastened with gasketed fasteners and is configured with simple laps.

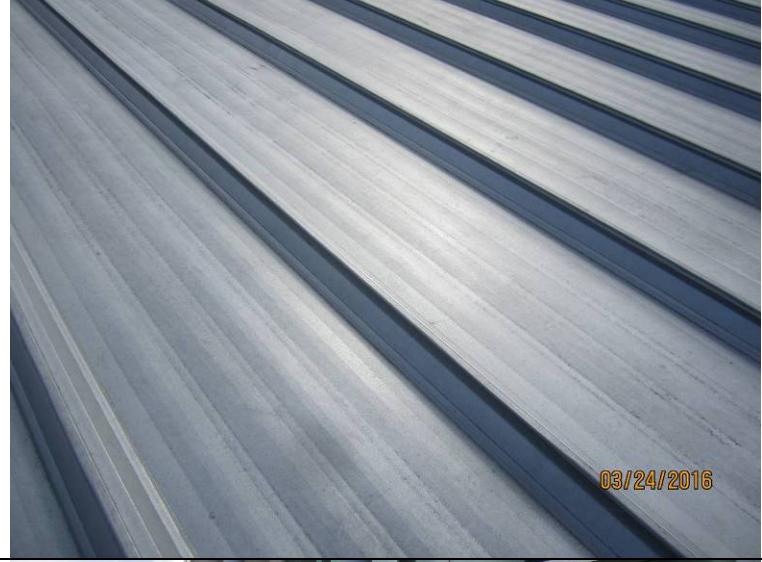
03/24/2016	Photograph 16: Trapezoidal seams of the sheet metal roofing.

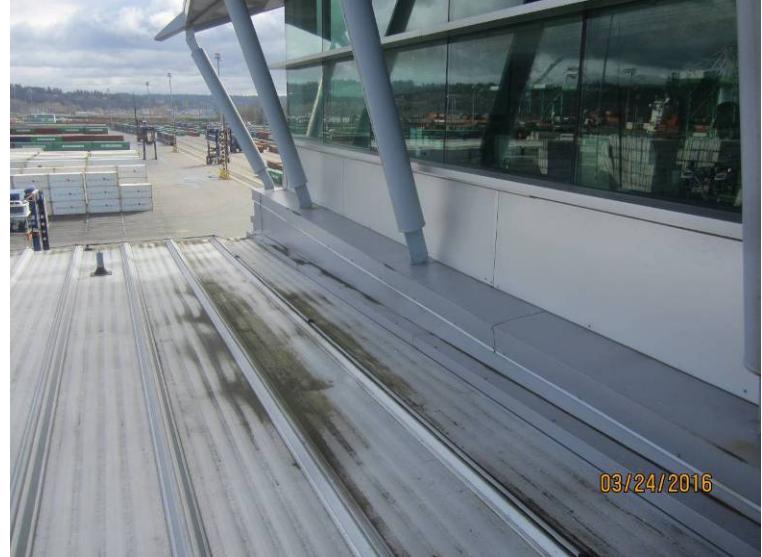
03/24/2016	Photograph 17: Transition to the rising building wall at the south side of the roof.

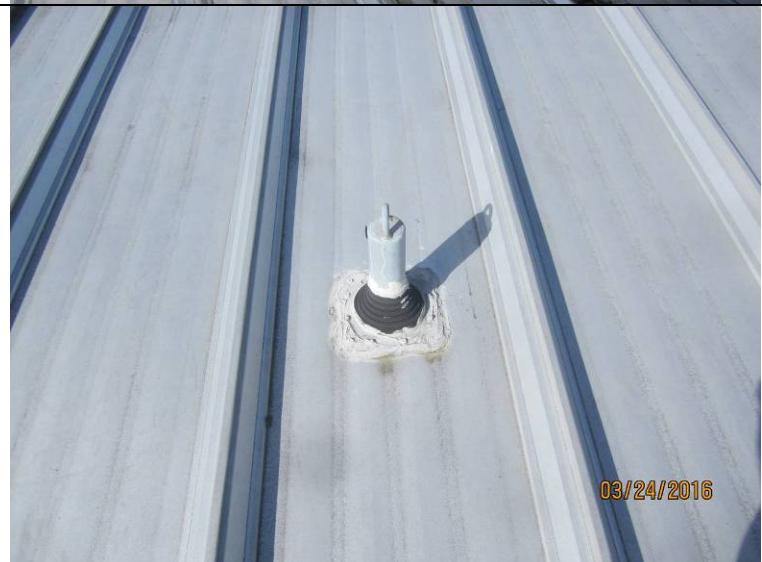
03/24/2016	Photograph 18: Fall protection anchor with sealant applied over the base of the through roof penetration flashing.

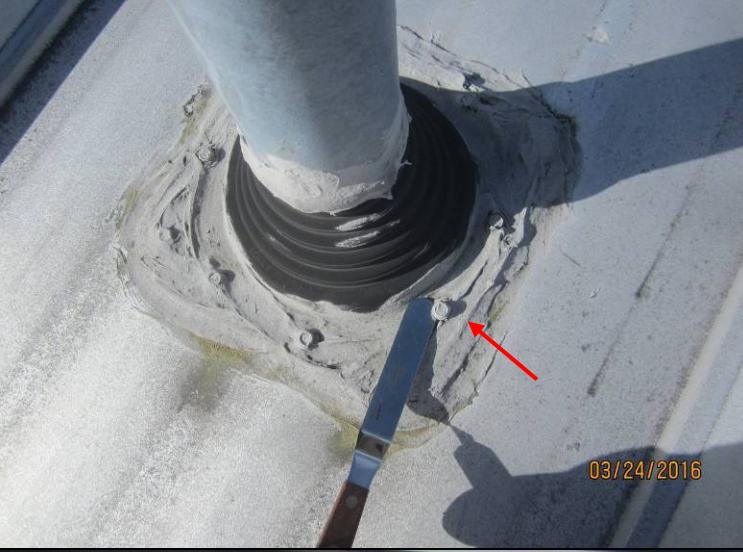
<p>Photograph 19: Through roof penetration flashing fastener that has backed out. This may be a source of water entry.</p>

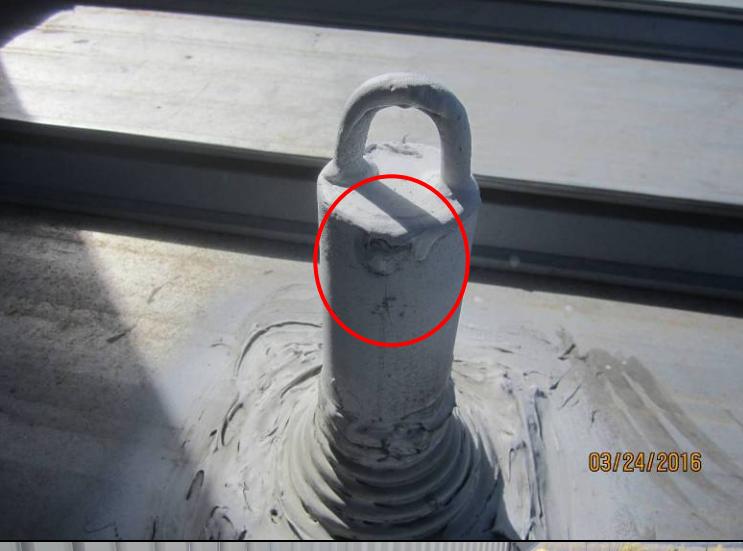
<p>Photograph 20: Sealant applied over the galvanizing relief hole at the lower roof area.</p>

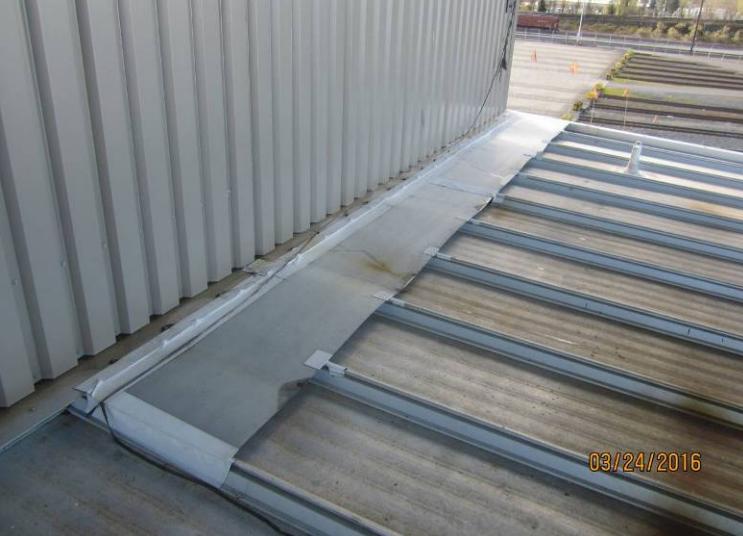
<p>Photograph 21: Extended base of wall flashing at the lower roof to rising wall transition. Reportedly the flashing was extended to stop previous water entry.</p>

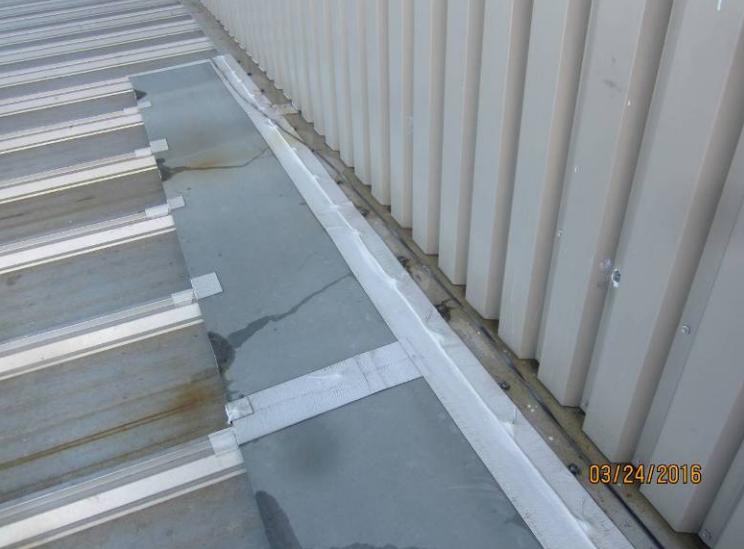
Photograph 22: EternaBond tape applied at the added flashing laps and transition to the existing flashing.

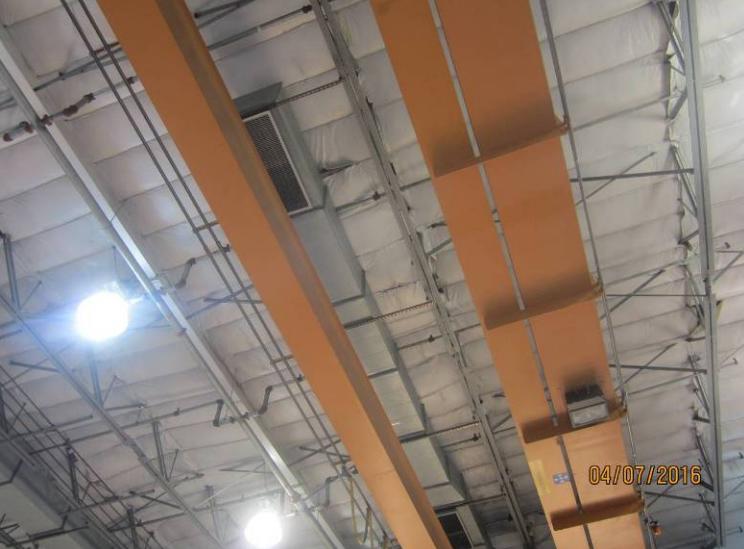
Photograph 23: Looking up at the underside of the insulation and vapor barrier form within the Maintenance Shop.

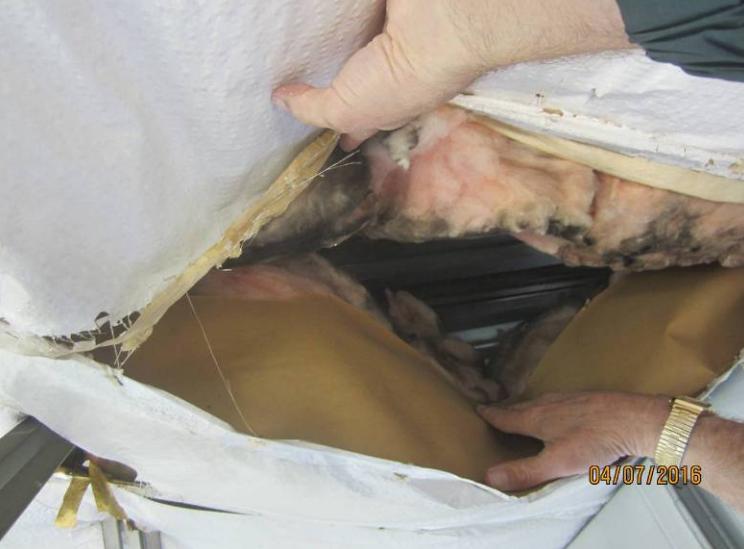
Photograph 24: Fiberglass batt insulation exposed.  The insulation shows signs of dirt accumulation.

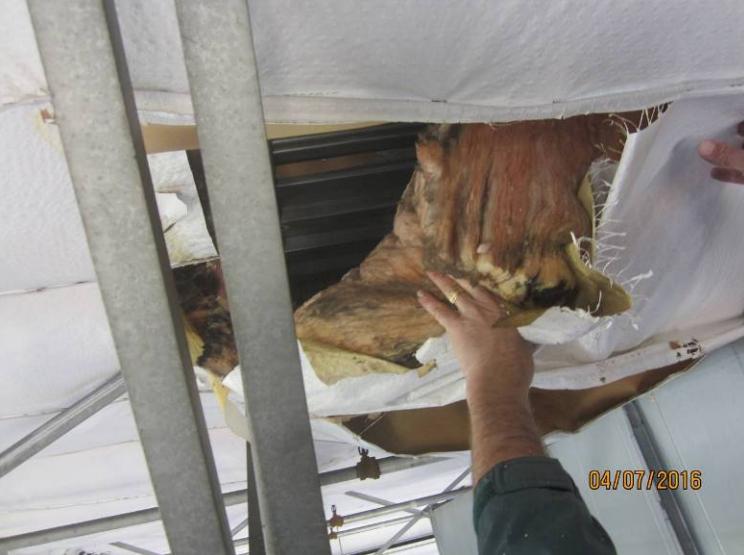
<p>Photograph 25: Additional location of exposed fiberglass insulation with signs of dirt accumulation. Dirt may be an indication of air movement over the insulation.</p>

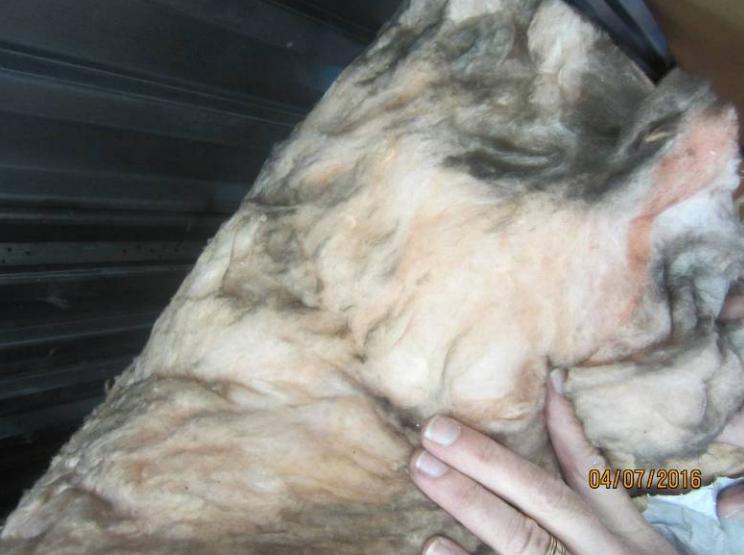
<p>Photograph 26: Closer view of the exposed insulation.</p>

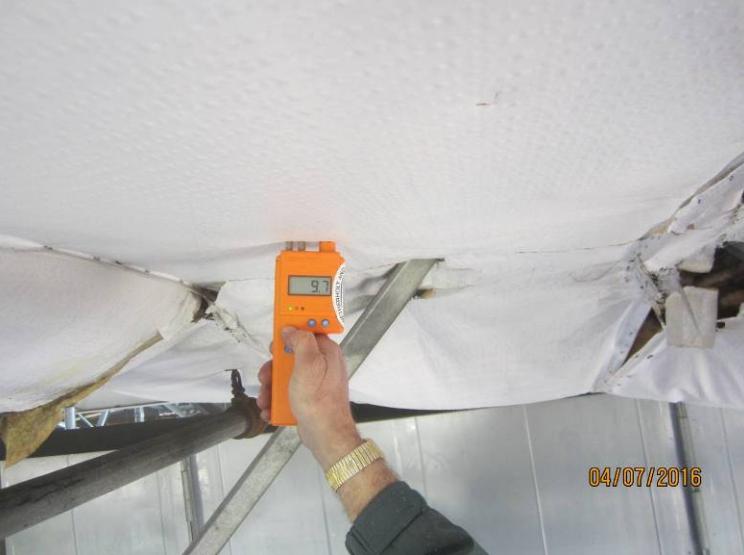
<p>Photograph 27: Delmhorst reading indicating low moisture.</p>

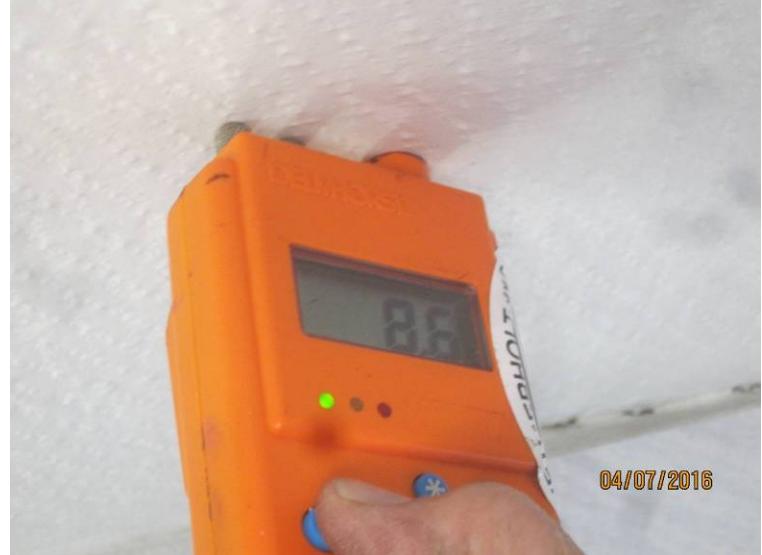
Photograph 28: Additional location of a Delmhorst reading indicating low moisture.

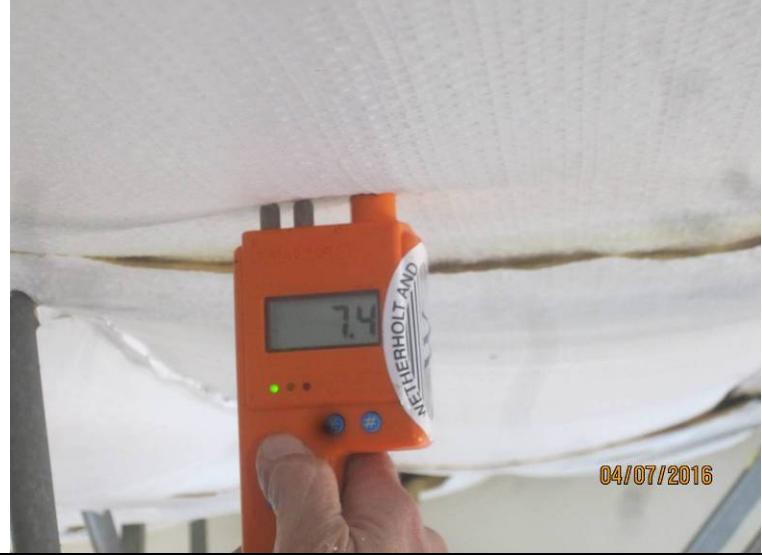
Photograph 29: Additional location of a Delmhorst reading indicating low moisture.

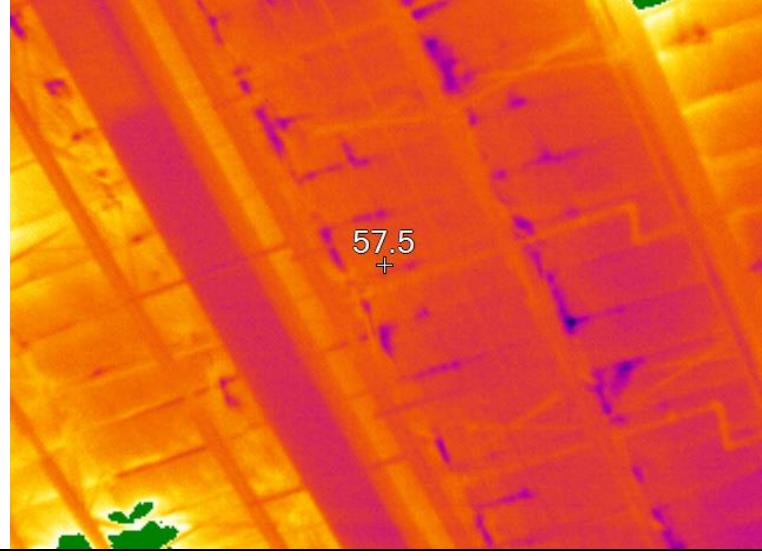
Photograph 30: Infrared image of the insulation.  The darker areas indicate colder areas.  Further investigation of the colder areas found the areas are voids in the insulation.

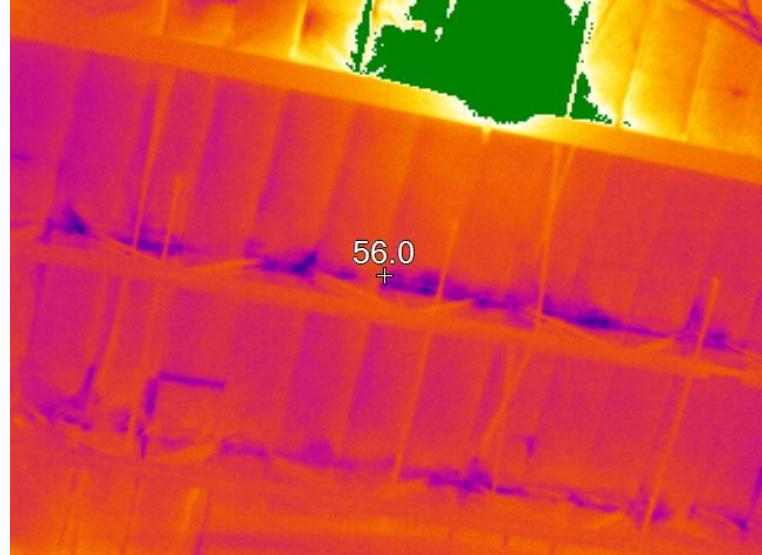
<p>Photograph 31: Infrared image of the insulation.</p> <p>The darker areas indicate colder areas.</p> <p>Further investigation of the colder areas found the areas are voids in the insulation.</p>

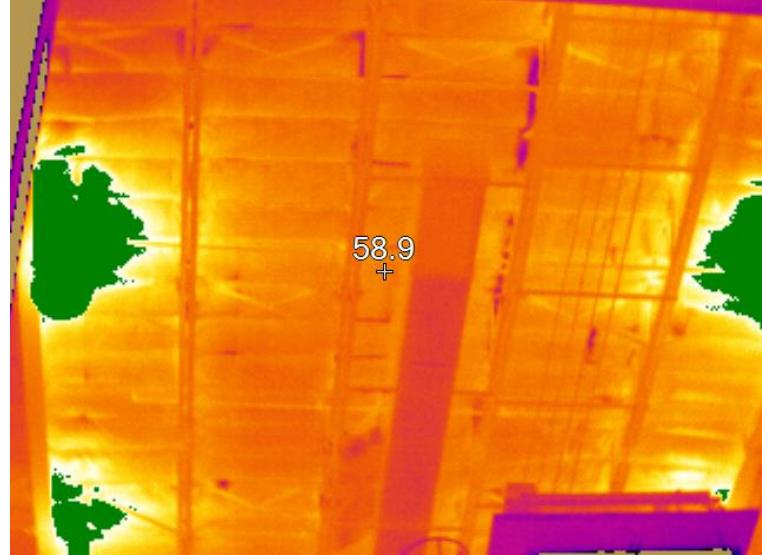
<p>Photograph 32: Infrared image of the insulation.</p> <p>The darker areas indicate colder areas.</p> <p>Further investigation of the colder areas found the areas are voids in the insulation.</p>

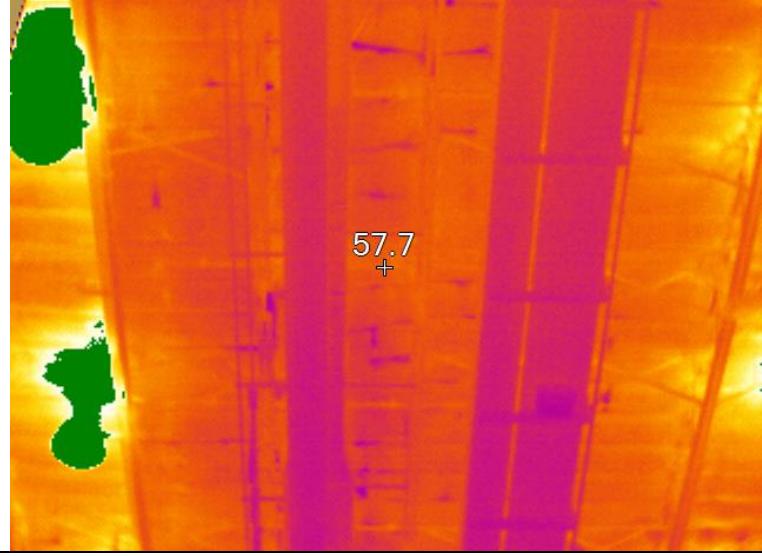
<p>Photograph 33: Infrared image of the insulation.</p> <p>The darker areas indicate colder areas.</p> <p>Further investigation of the colder areas found the areas are voids in the insulation.</p>

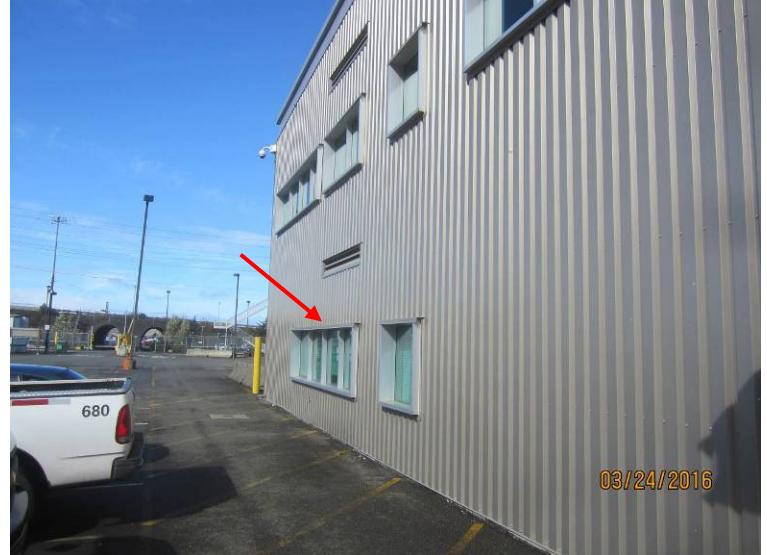
Aluminum framed storefront window at the break room located at the south side of the building shows signs of water entry at the head of the window and damage to the drywall at the window sill. The damaged dry wall is likely due to water collecting from above. Infrared images show an area of differential in temperature above the window emanating from below a louver. It appears the louver, or sealant joint at the perimeter of the louver is allowing water to penetrate into the wall assembly.

<p>Photograph 34: Overview of the south elevation of the break room. The arrow indicates the window where signs of water entry were observed in the interior.</p>

At the south elevation, the louvers should be removed, soldered stainless steel sill pans installed, the louvers reinstalled and new properly configured sealant joints installed around the louvers leaving weeps at the sill. If moisture entry continuous after proper installation of sill pans, the sheet metal cladding assembly should be removed to allow the weather barrier to be reviewed and repaired where necessary to provide a weather tight installation. Remove the sealant joints around the windows and replace with new properly configured sealant joints.

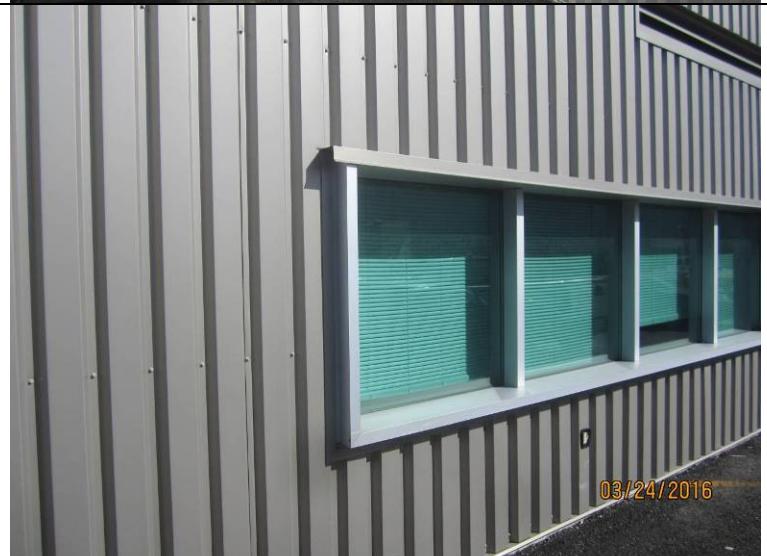
<p>Photograph 35: Closer view of the window shown in Photograph 34.</p>

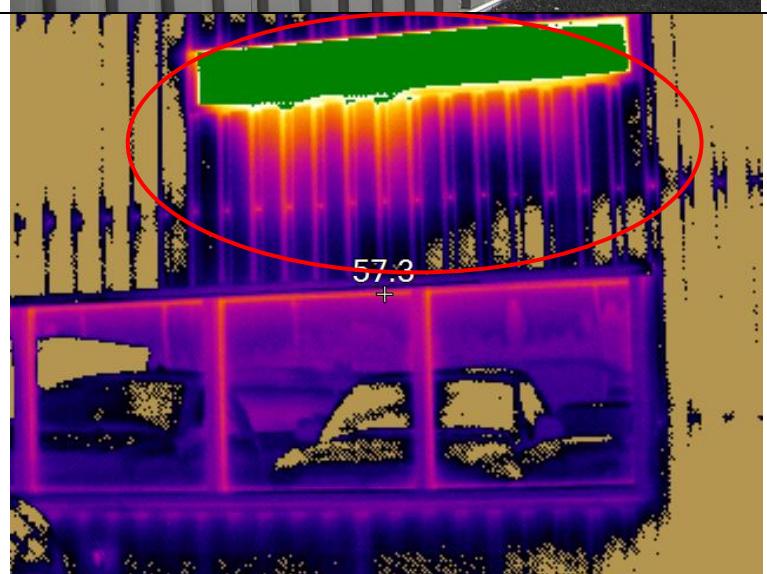
<p>Photograph 36: Infrared view of the window shown in Photograph 34. Note the temperate differential below the louver and above the window head. This type of temperature differential may indicate components have been wetted thereby reducing the components thermal resistance.</p>

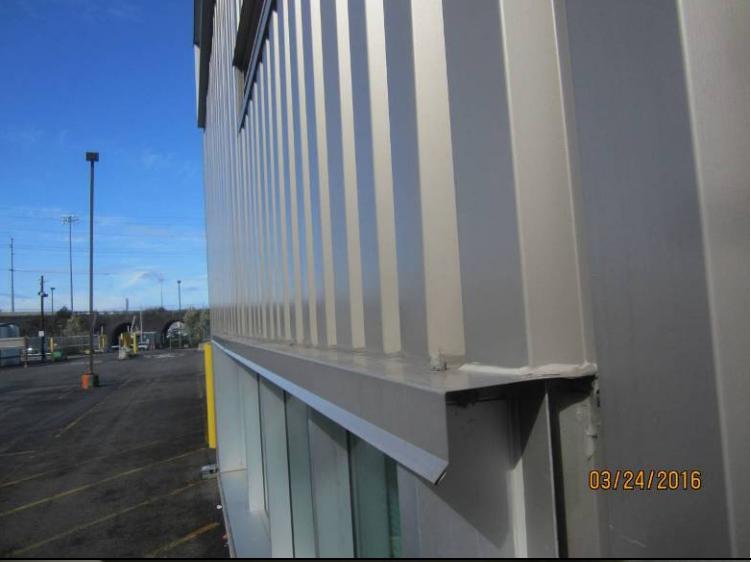
A photograph showing the exterior of a building with vertical siding. A window is visible, and the head flashing is being evaluated. The date 03/24/2016 is overlaid in the bottom right corner.	Photograph 37: Looking across the head flashing at the window shown in Photograph 34.

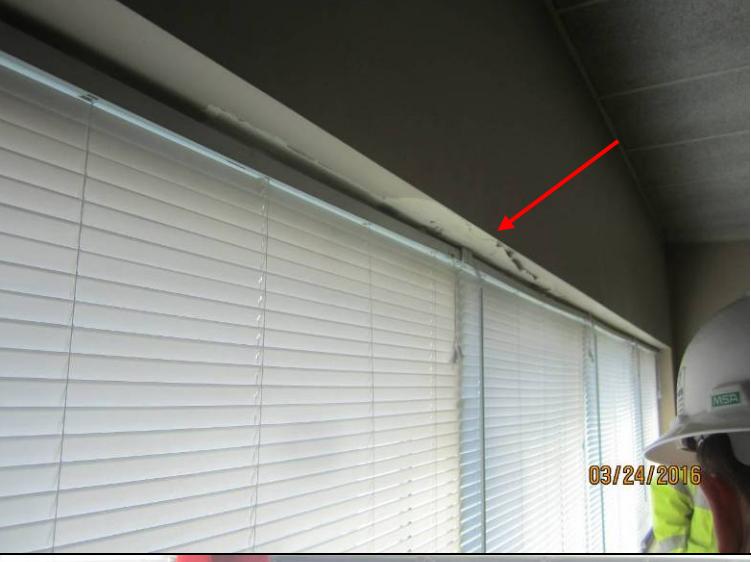
A photograph taken from inside a building, looking out at a window. A red arrow points to the head of the window, highlighting an area of concern. The date 03/24/2016 is overlaid in the bottom right corner.	Photograph 38: Interior view of head of the window shown in Photograph 34.  The drywall and paint show signs of water damage.

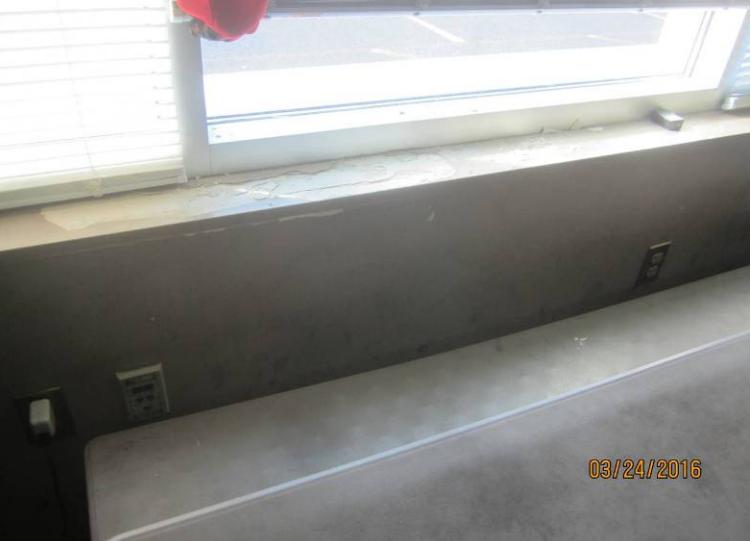
A photograph taken from inside a building, looking out at a window. The sill of the window is visible, and the drywall and paint show signs of water damage. The date 03/24/2016 is overlaid in the bottom right corner.	Photograph 39: Interior view of sill of the window shown in Photograph 34.  Note the drywall and paint show signs of water damage.

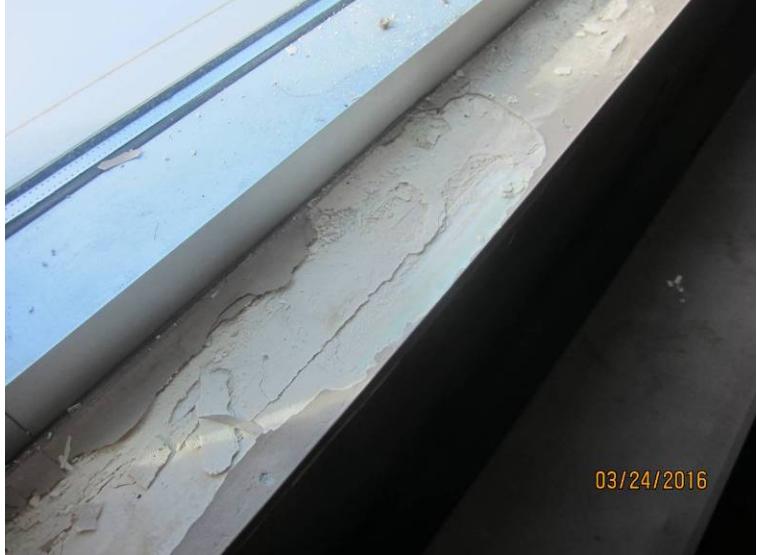
<p>Photograph 40: Closer view of the area shown in Photograph 39.</p>

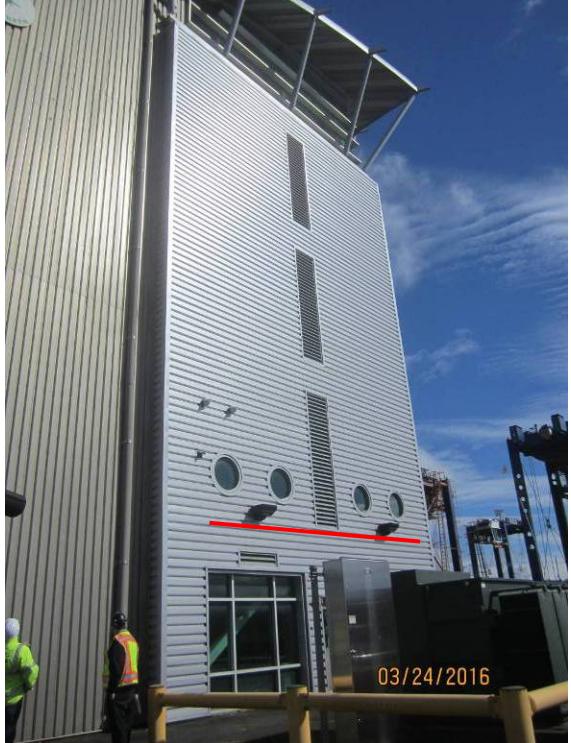
Signs of water entry were also observed at the south elevation in the interstitial/storage space below the control tower. Water was observed below the round windows, and louvers within the stud track. Infrared images did not indicate any anomalies.

<p>Photograph 41: Overview of the south elevation below the control tower.</p> <p>The line shows the approximate location of the sill track with water observed.</p>

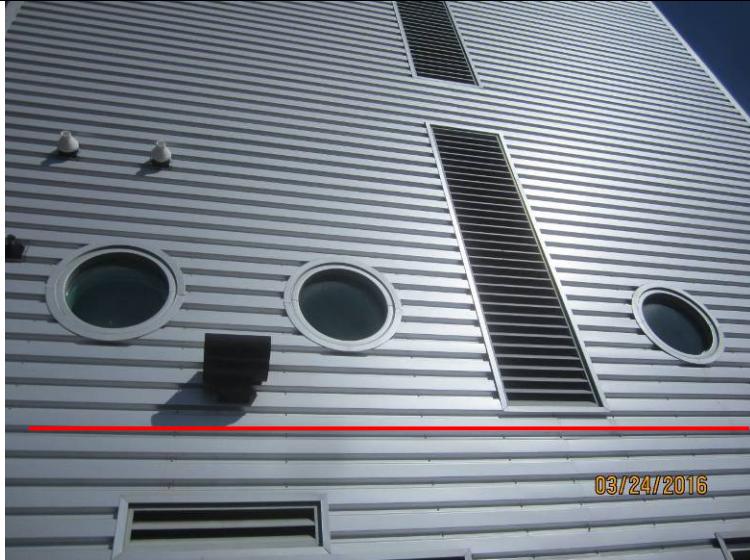
<p>Photograph 42: Closer view of the area shown in Photograph 41. The line shows the approximate location of the sill track with water observed.</p>

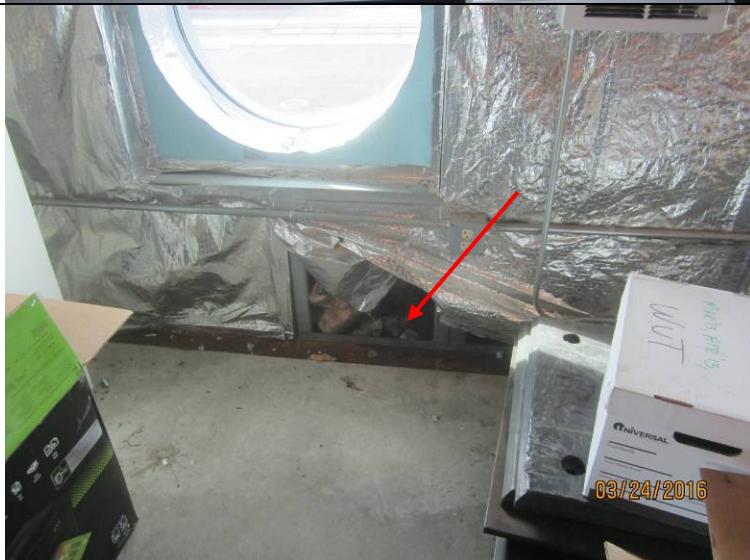
<p>Photograph 43: Interior view of the area below the control tower. The arrow indicates the sill track where water was observed.</p>

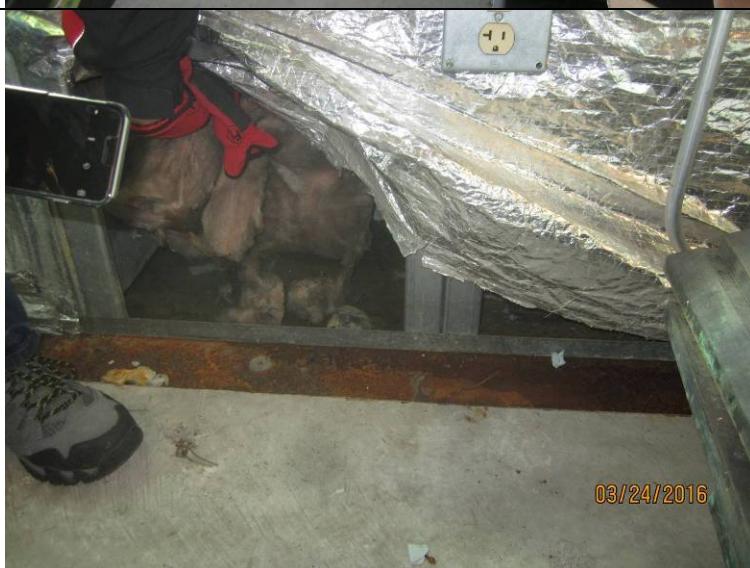
<p>Photograph 44: Closer view of the area shown in Photograph 43.</p>
