TO: Building 532 (also referenced as 9532) Structural Repairs Bid Specification

SUBJECT: RFP NO. 071646

ADDENDUM NUMBER # 03

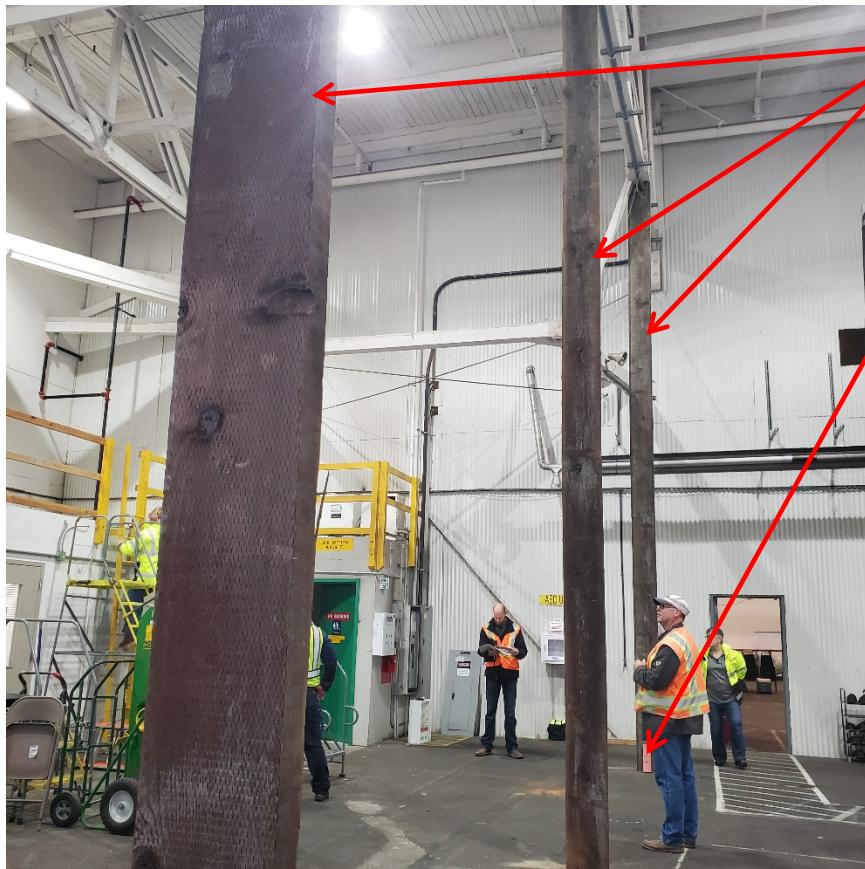
Photo 1: Temporary Shoring Location #1

Question 1: Who is responsible for removing the existing temporary shoring?

Response 1: Contractor shall include the removal and of existing wood shoring columns at four (4) locations, refer to Photos 1 and 2. Coordinate storage onsite for pickup by Port of Tacoma maintenance personnel.

Remove 3 existing wood shoring columns along grid "G" between grids 7-9. Coordinate onsite storage and pickup with Port of Tacoma maintenance staff.

Remove existing post base and grind any penetrations flush to concrete.

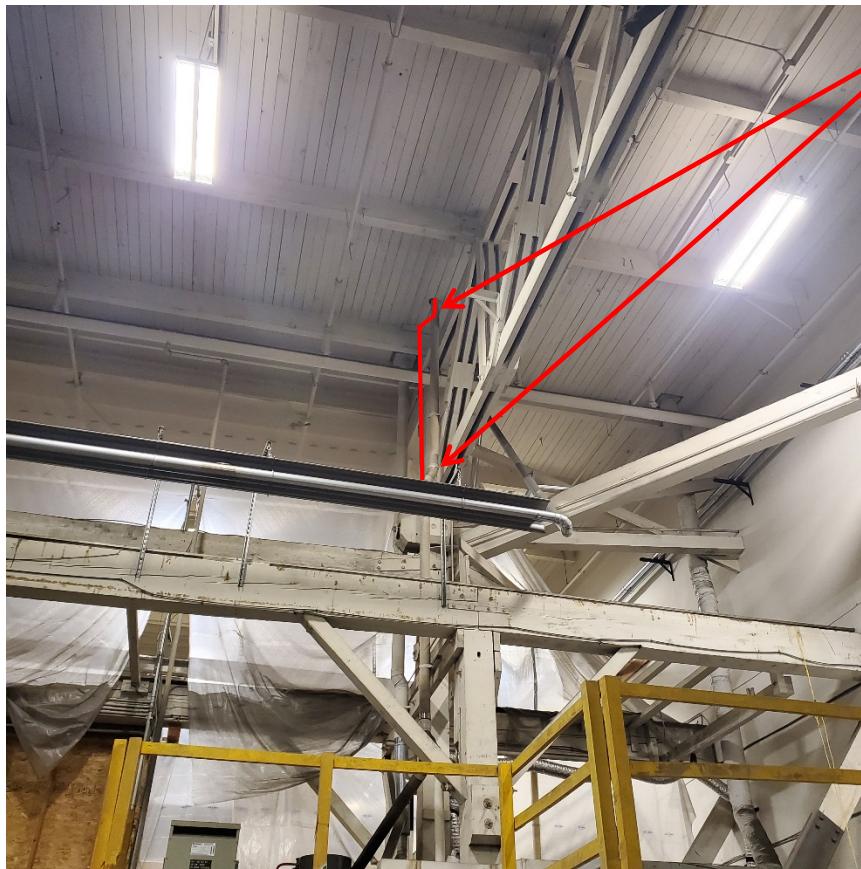
Photo 3: Existing Rainleader at Grid E-13

Question 2: At the intersection of grids E-13, there is an existing rainleader that conflicts with the proposed truss repair. Please advise.

Response 2: Modify existing rainleader to elbow out above the existing truss, refer to Photo 3.

Relocate elbow and modify existing rain-leader to provide sufficient clearance off face of existing truss to accommodate new glulam beam (approx. 7", field verify).

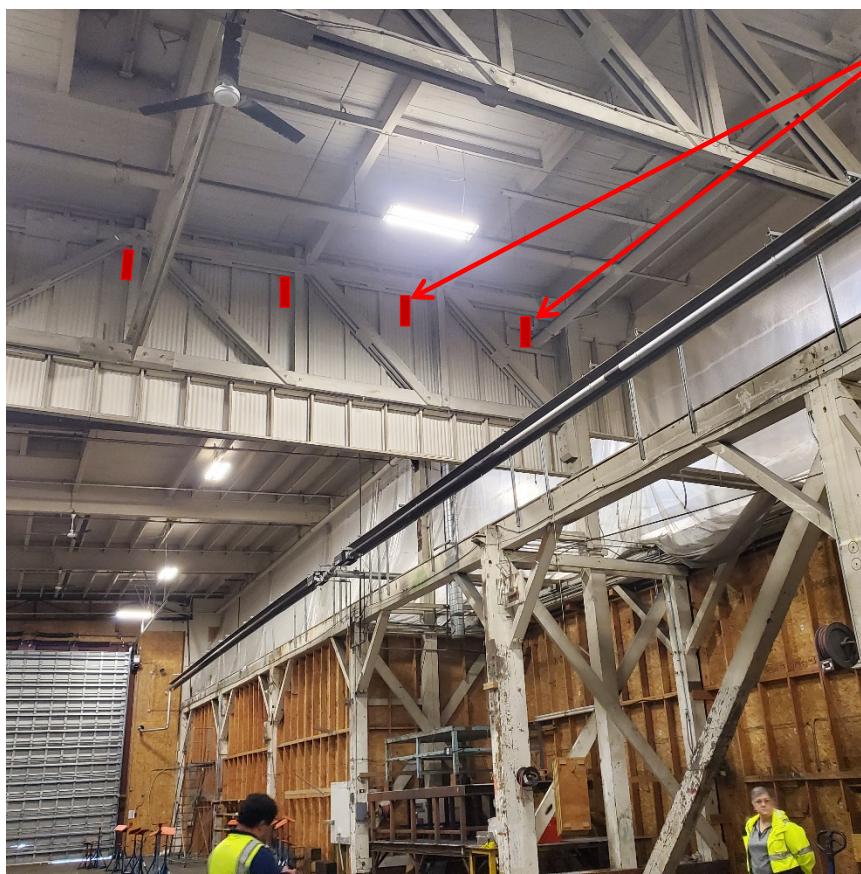
Photo 4: Existing Draft Curtain at Gridline G

Question 3: There are two existing draft curtains at occur at two (2) trusses along gridline G. Please advise how new glulam beams should be attached here.

Response 3: Provide new penetrations through existing metal panels to accommodate new 4X6 ladder framing at 4'-0" o.c. per detail 4/S3.0. Cut openings tight to new framing, refer to Photo 4.

Provide new penetrations through existing metal panels for new 4x6 ladder framing, refer to structural plans for spacing and quantity. Cut holes tight to new framing.
