**UNDERGROUND STORAGE TANK
SITE ASSESSMENT / SITE CHARACTERIZATION**

Sea-Land Container Terminal

Located at:
1675 Lincoln Avenue
Tacoma, Washington

Revised: February 19, 1999

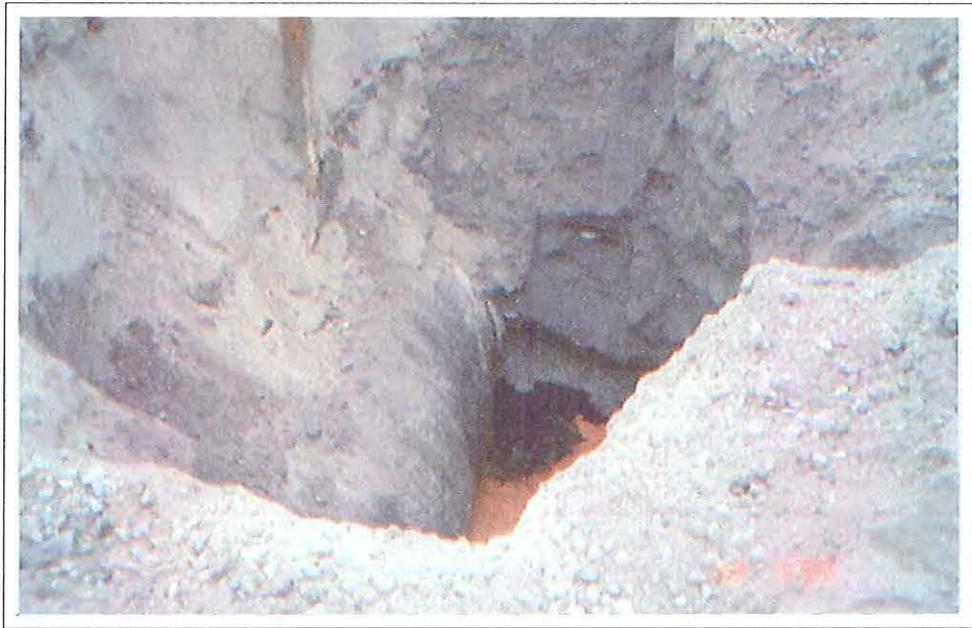
During the excavation of the UST on December 7, 1998, a strong diesel odor was observed from the excavation. As the UST was excavated free diesel product was observed on the surface of ground water at a depth of 8.0 feet BGS (below ground surface). On site analysis using the Petroflag Hydrocarbon Analyzer indicated the presence of hydrocarbons in the excavated soils.

UST excavation with UST exposed and oil observed floating
on the groundwater

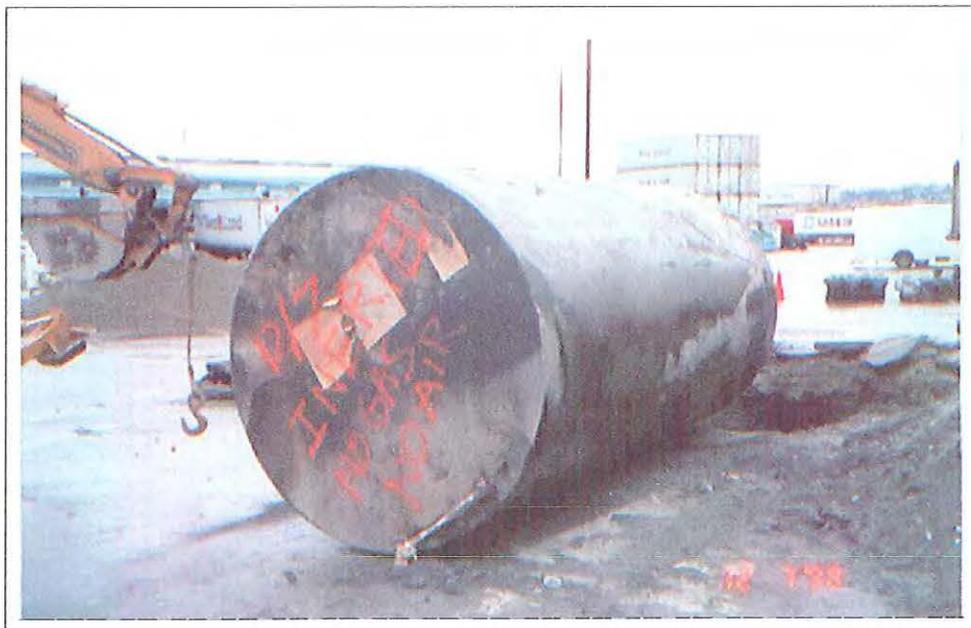
The UST was examined following removal from the excavation and appeared in good condition. There was minimal evidence of scaling, pitting or rusting present on the surface of the UST. The UST was placed on a truck and disposed of through Northwest Tank and Environmental at 12720 4th Avenue W Suite F 406, Everett, Washington, 98204 by Marine Vacuum Services and recycled at a local scrap metal recycling facility.

3000 gallon UST following removal from excavation

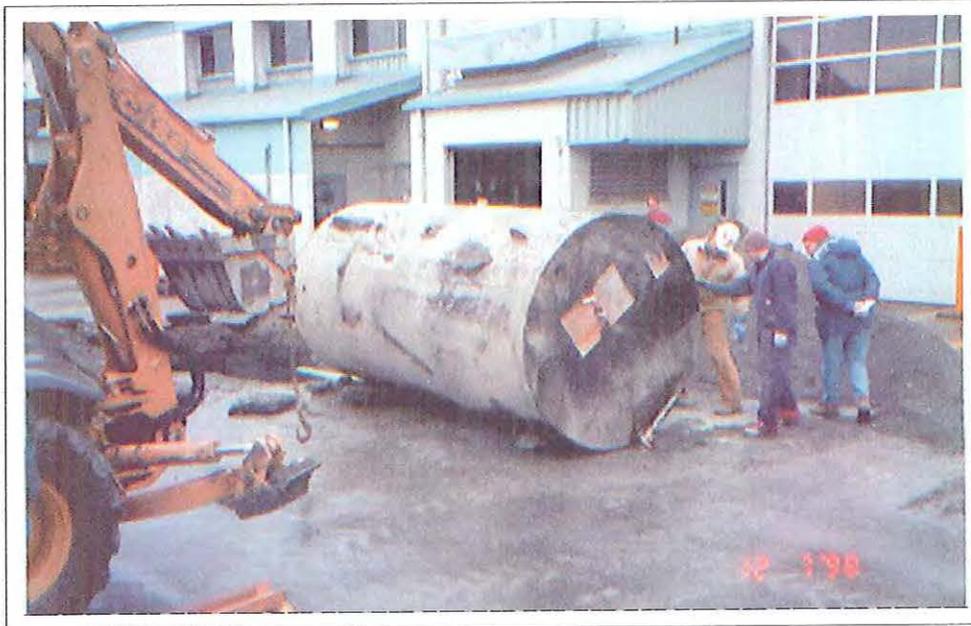
The client requested that CETI investigate the origin of the contaminate. CETI inspected the tank and related piping. The tank did not appear to have any leaks, was minimally pitted and appeared to be in excellent condition. The piping appeared to be tight, and in excellent condition as well. There did not appear to be contamination at or near the vent pipe or the fill pipe. Soil at the location of the pipe was a sandy material which had no odor nor staining. The odor of diesel and the staining by what appeared to be hydrocarbon material, were encountered at a lower portion of the excavation.

3000 gallon UST following removal from excavation. Inspection of the UST showed had no visual evidence of pitting, scaling or holes in the UST.

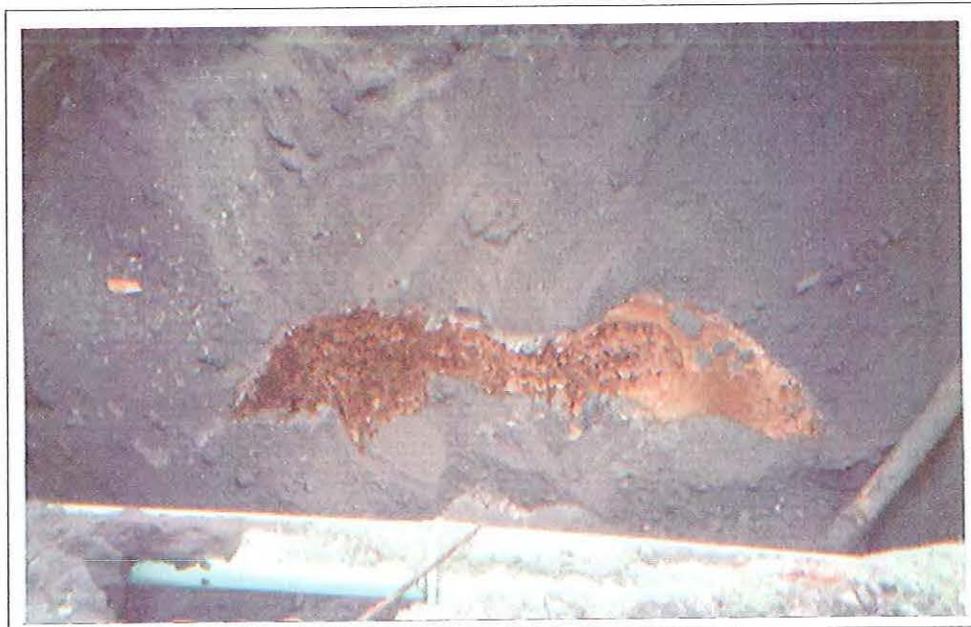
Diesel oil observed floating on groundwater in UST Excavation

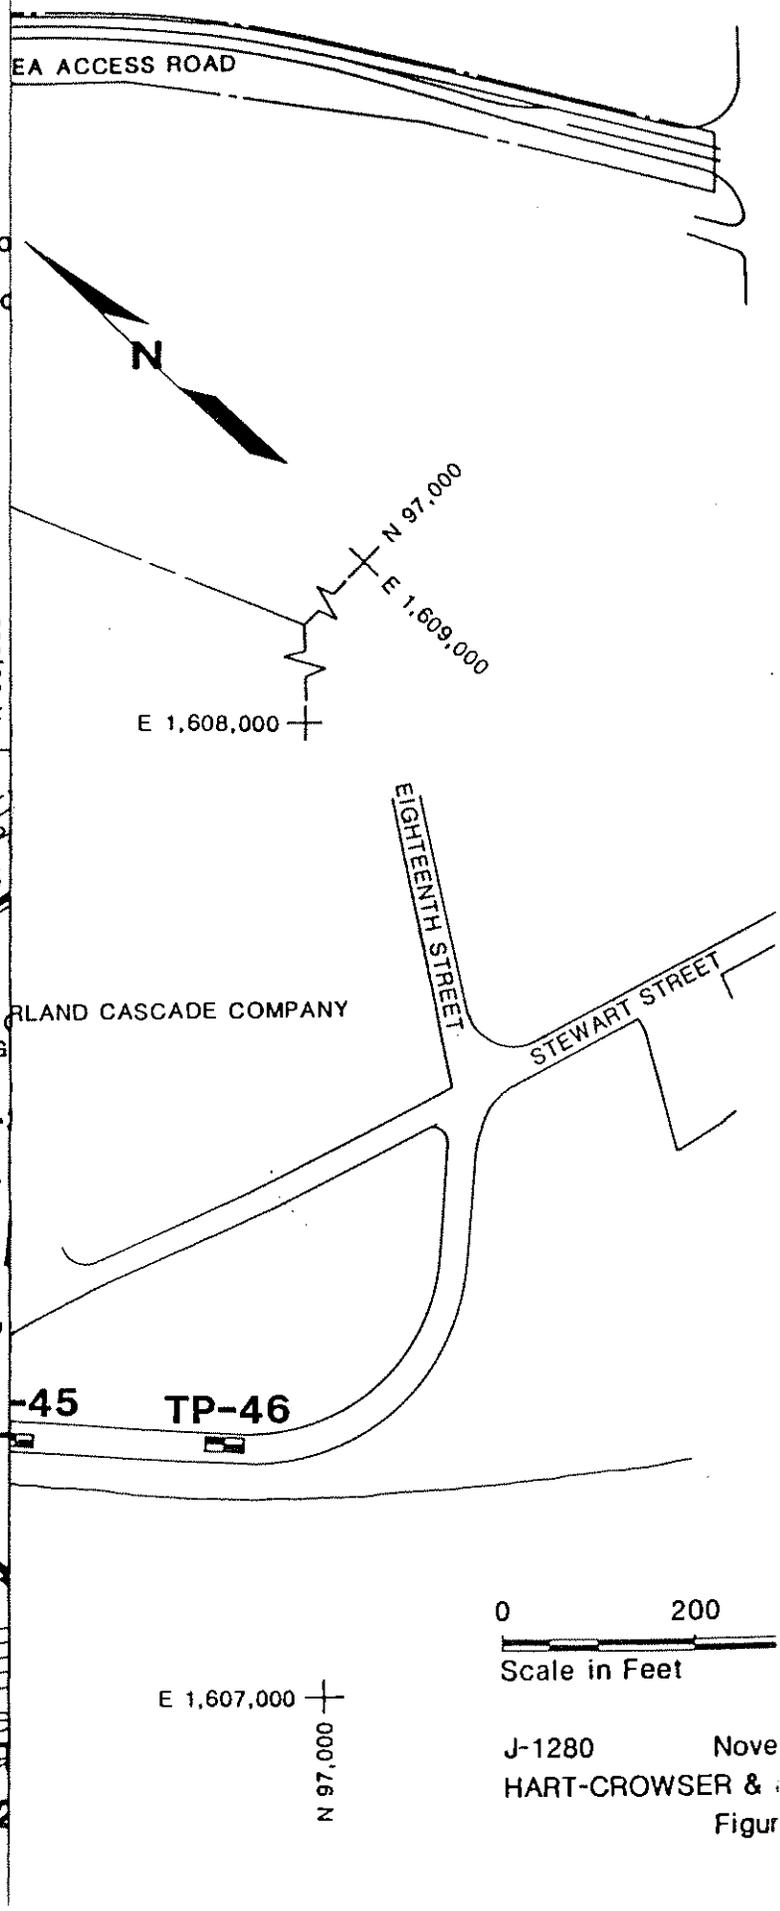
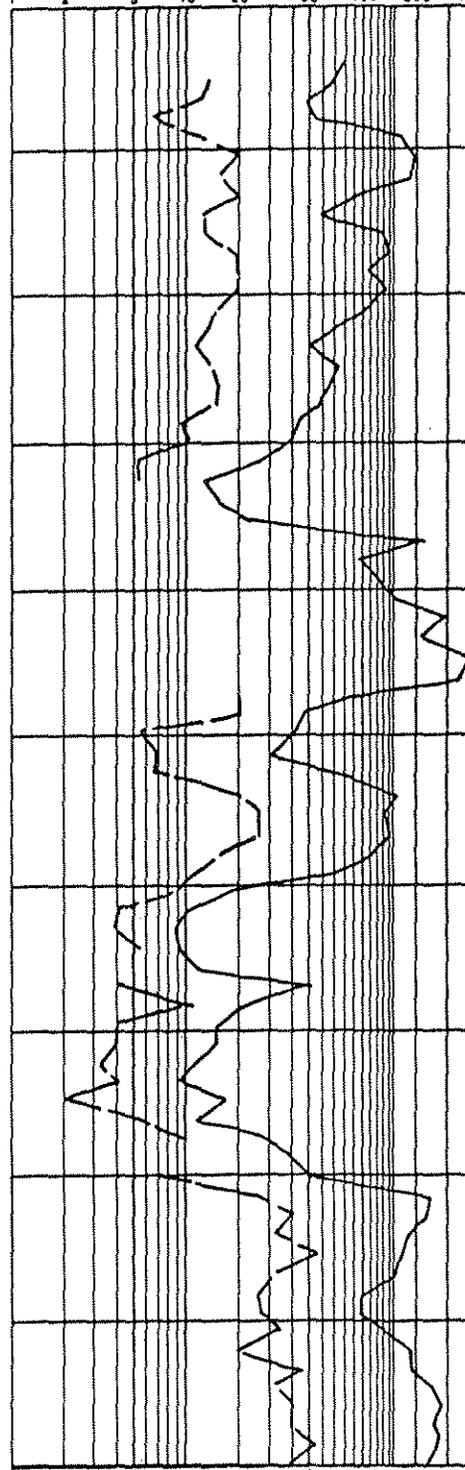
Probe Log P-1

Dense.
Silty layer.
Bottom of Probe 60.3 Feet. Completed 7/24/83.

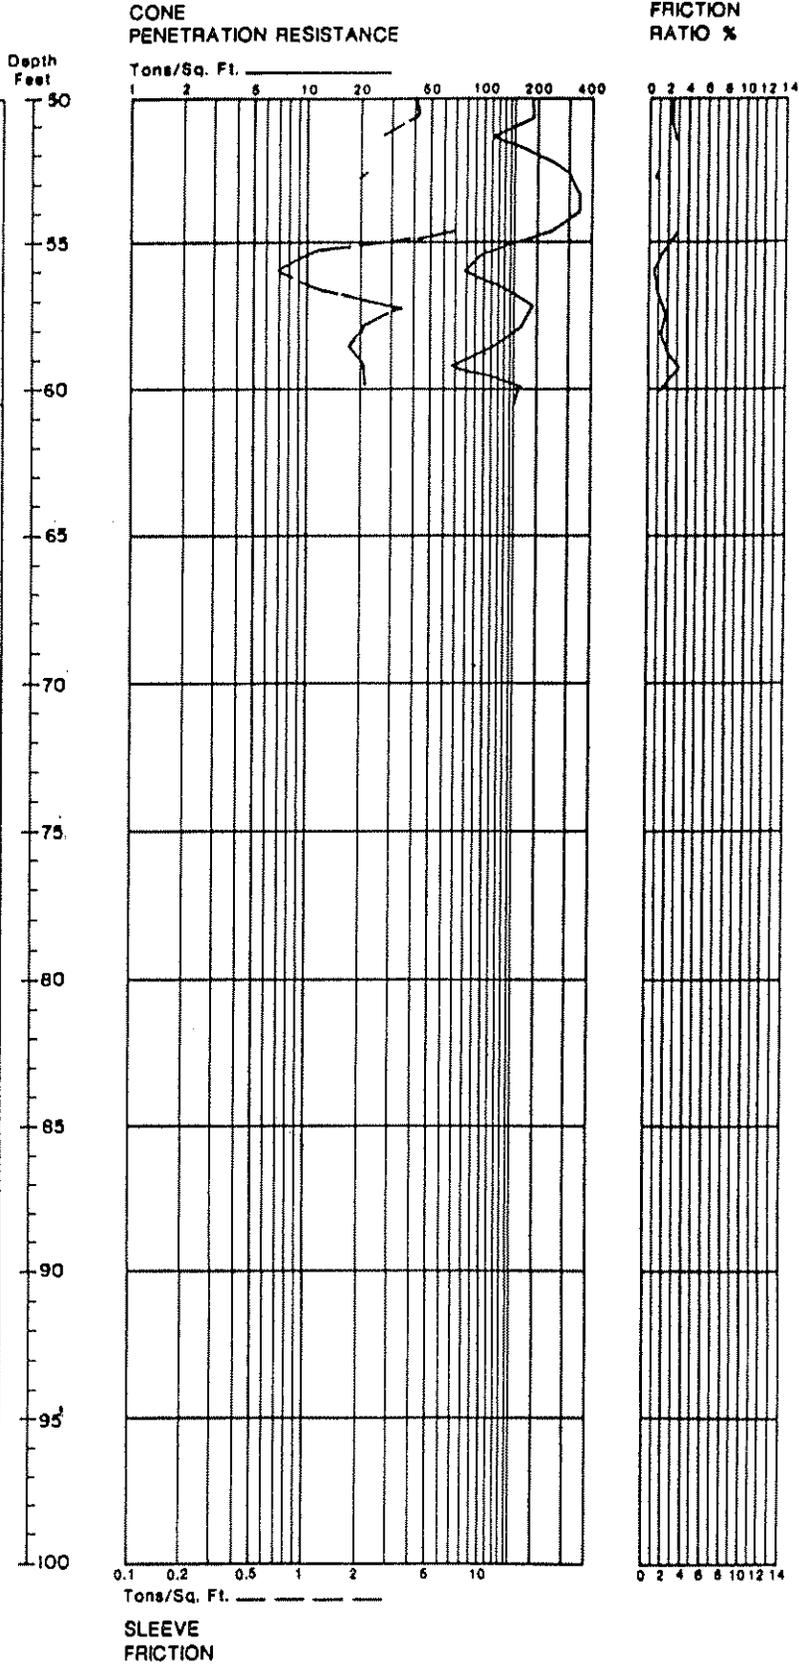
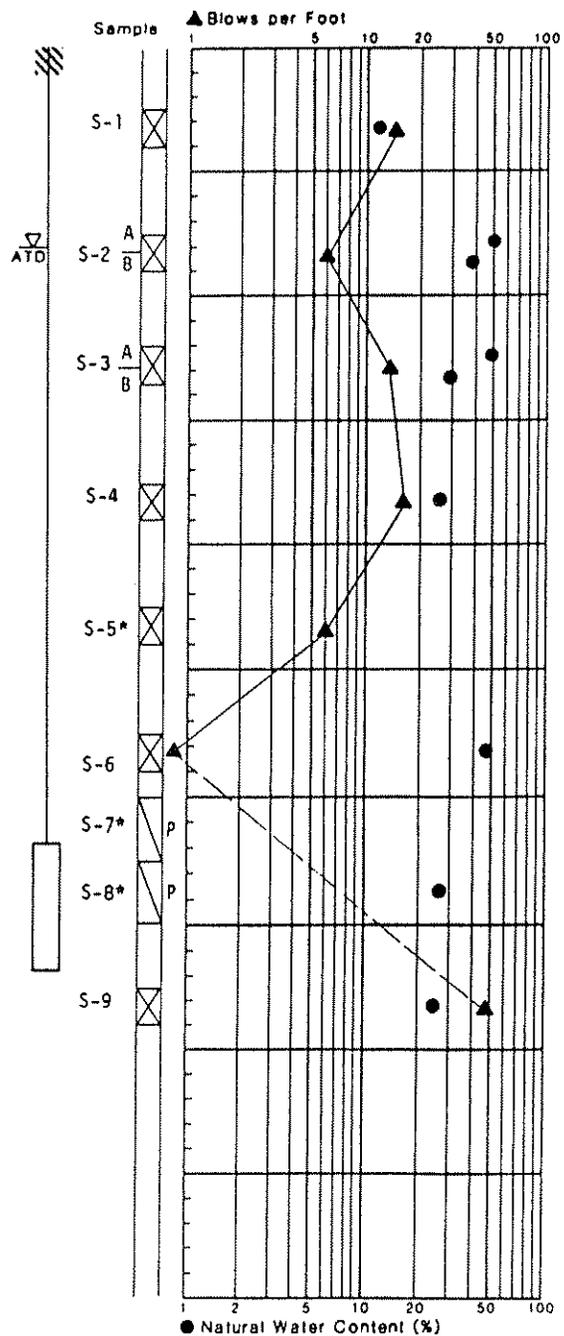
Boring Log B-1

Medium dense, moist, brown, fine to medium SAND. (FILL).	0
Soft, wet to saturated, dark brown, slightly clayey SILT with scattered organics.	5
Loose to medium dense, saturated, dark gray, silty, fine SAND with scattered organics and fine sandy SILT interbeds.	10
Loose to medium dense, saturated, dark gray, fine to medium SAND with scattered root and shell fragments.	15
Very soft, wet to saturated, light gray to brown, slightly fine sandy, clayey SILT with numerous organics.	20
Medium dense to dense, saturated, dark gray to black, fine to medium SAND.	25
Bottom of Boring at 39.0 Feet. Completed 7/20/83.	30
	35
	40
	45
	50
