PROJECT: Thorne Road Off Dock Container Yard

SUBJECT: Summary of Potential Areas of Soil and Groundwater Contamination

DATE: February 25, 2020

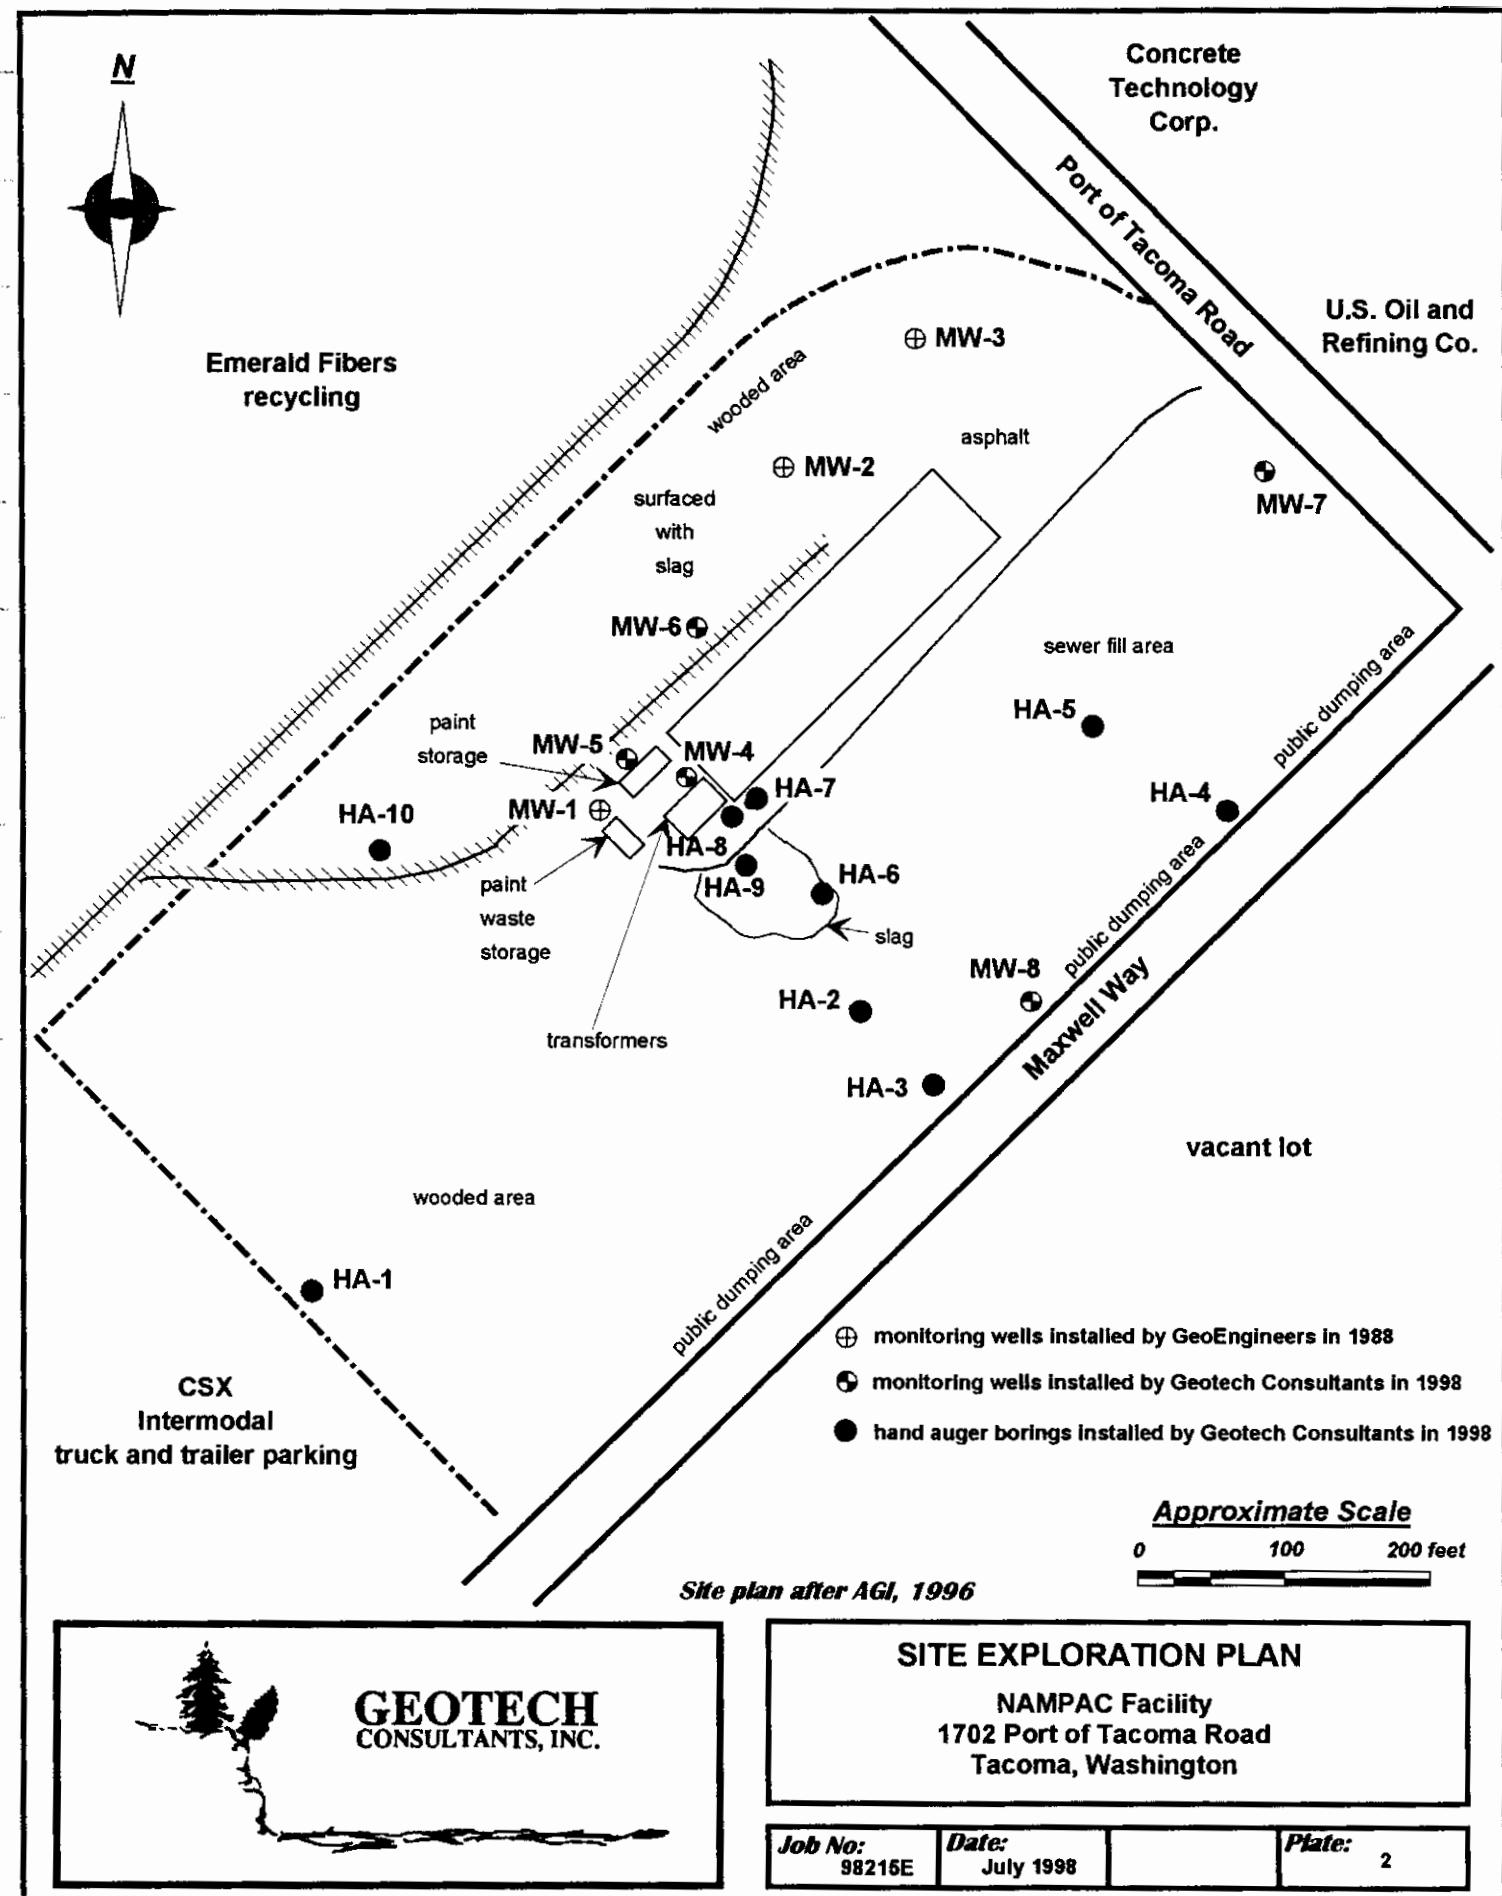
SITE EXPLORATION PLAN
NAMPAC Facility
1702 Port of Tacoma Road
Tacoma, Washington

Analysis of soil samples from HA-1 revealed concentrations of diesel- and heavy oil-range petroleum hydrocarbons in excess of current MCTA cleanup requirements. Although a soil sample from the compressor area (HA-8) found no evidence of petroleum contamination, a previous report by AGI noted that some petroleum-contaminated soil apparently remains in that area. Soil samples at all other locations were within MTCA cleanup standards for all analytes.

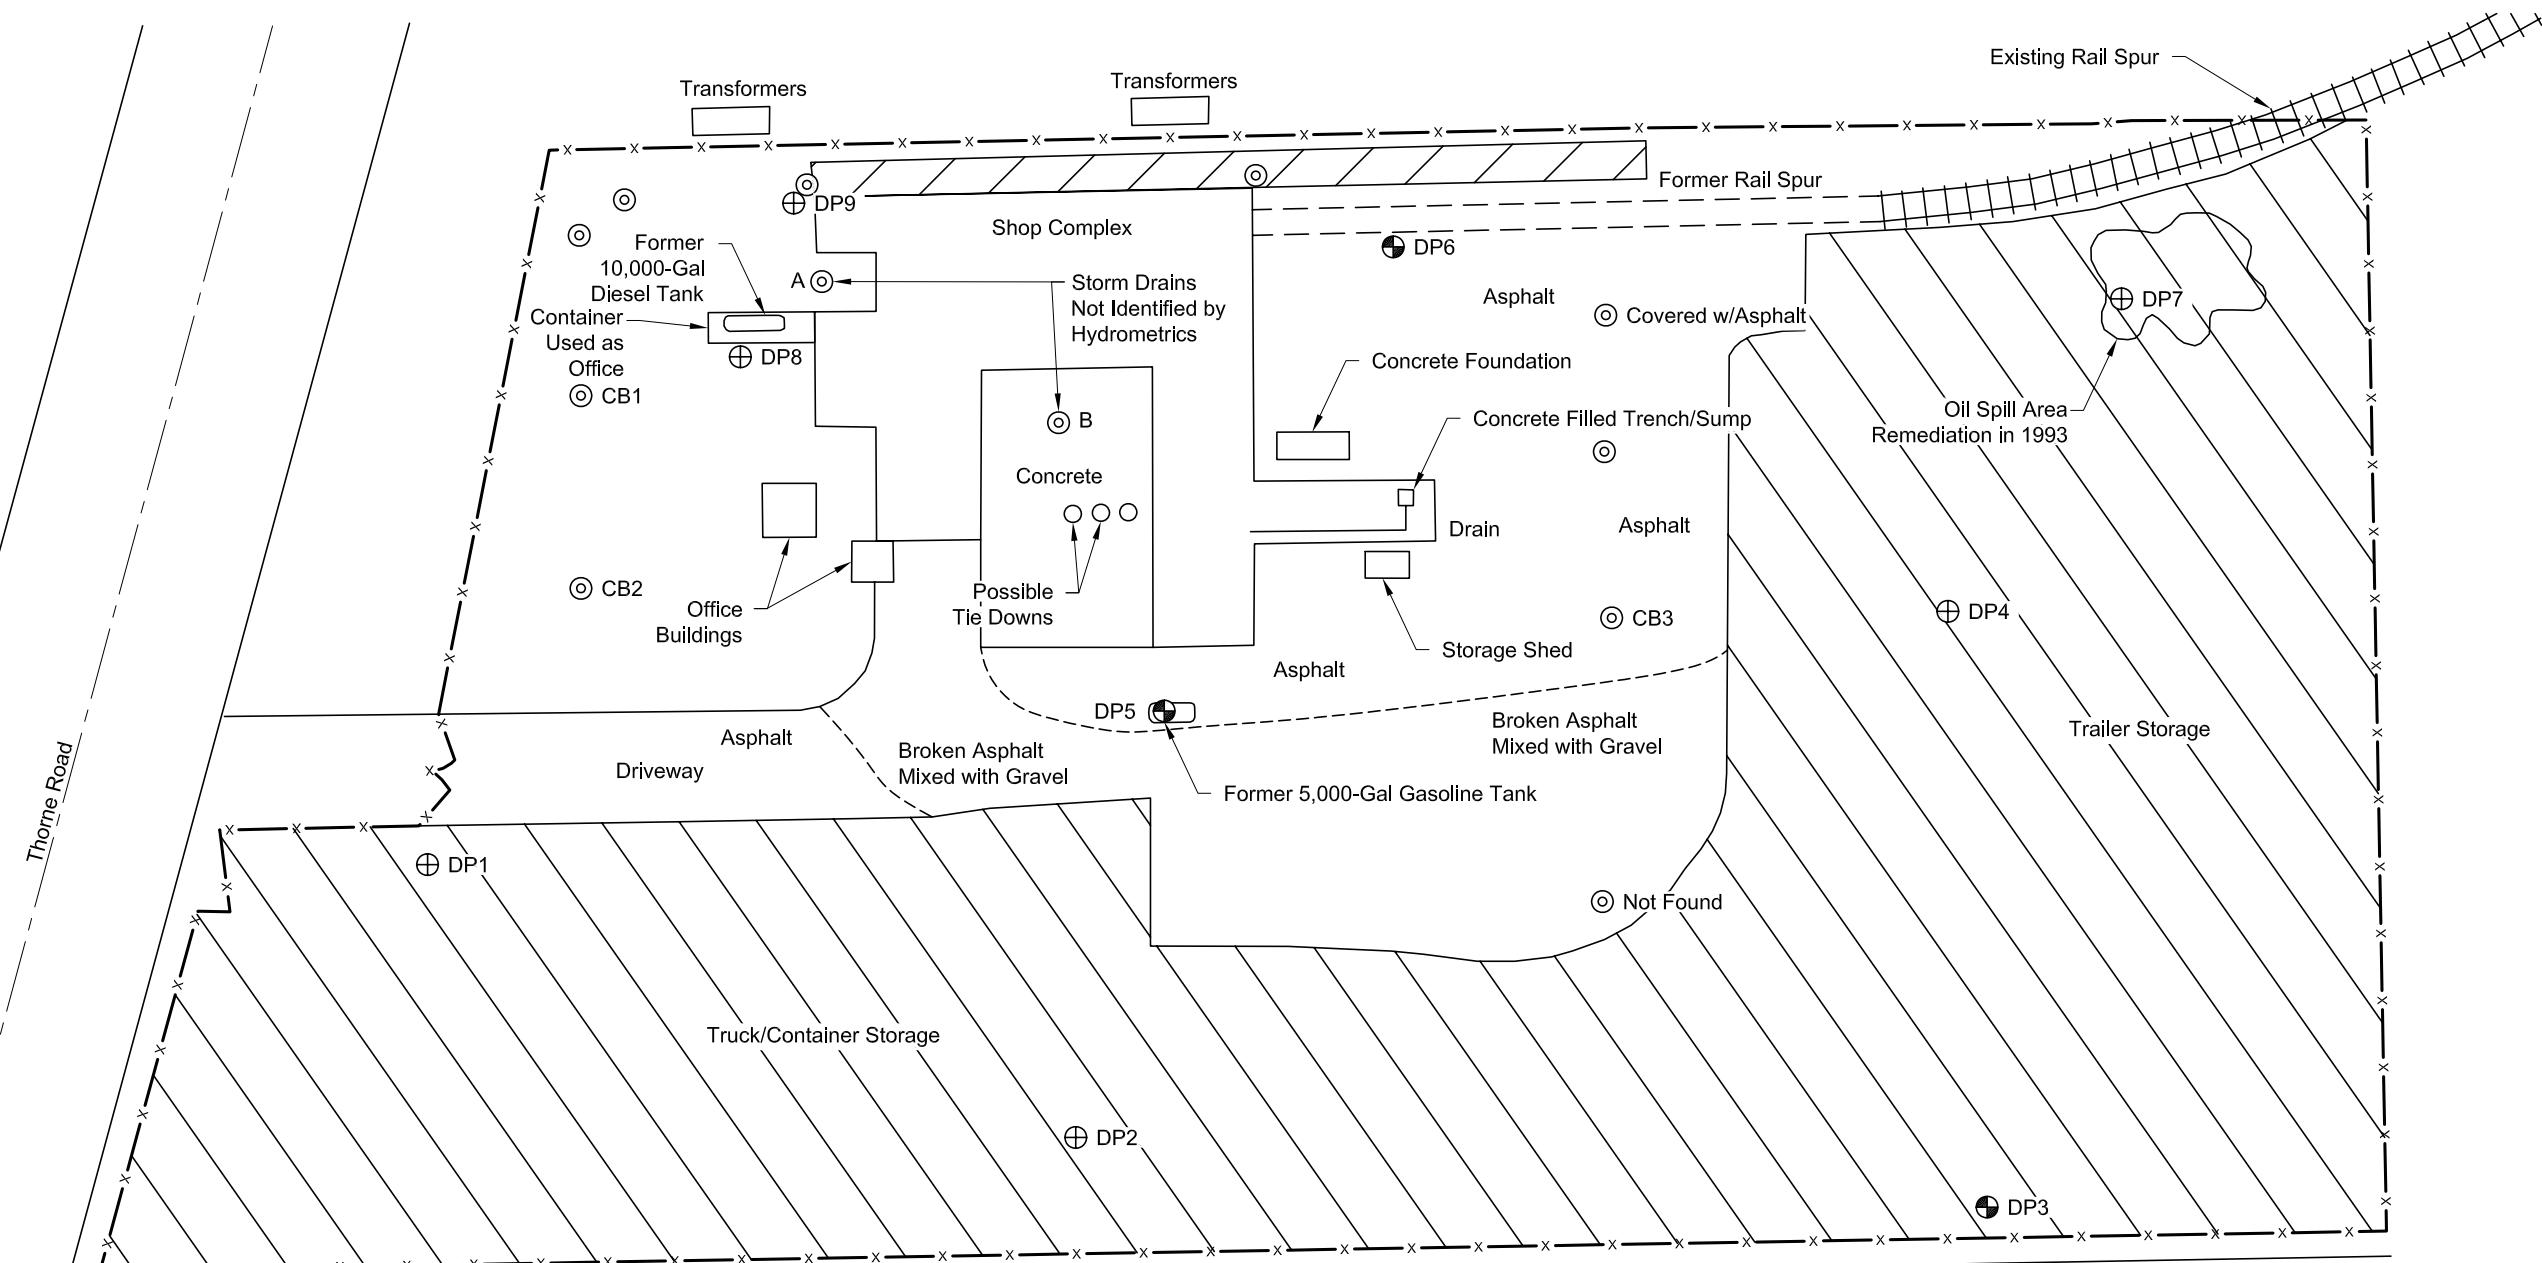
Thorne Road Property
Tacoma, Washington**Site Plan****Figure 2**

Based on the results of the Focused Phase II sampling and analysis, no conditions of environmental concern are identified at the subject property. The analytes detected in the storm drain system are those commonly found in industrial surface water runoff. The current condition of the storm drains likely makes the system only partially functioning. Several of the catch basins could not be accessed or were reported as abandoned. The storm drain catch basins should be cleaned to improve their effectiveness. The solids and water generated during the cleanout work should be managed by appropriately trained personnel, such as a licensed environmental services contractor, for appropriate disposal per applicable Ecology regulations. In addition, due to the previous widespread use of slag in the subject property area, some localized areas with residual slag would be anticipated on the subject property (such as was detected beneath the asphalt at location DP6). These small amounts of slag are not considered to be of concern. However, if the soil is excavated, then the presence of slag should be considered in the planning for disposal of the material.
